Gas Well Study, 2012

George Monk and Molly Schaffnit
March 2013

Gas Well Study is the examination of natural gas wells in West Virginia.

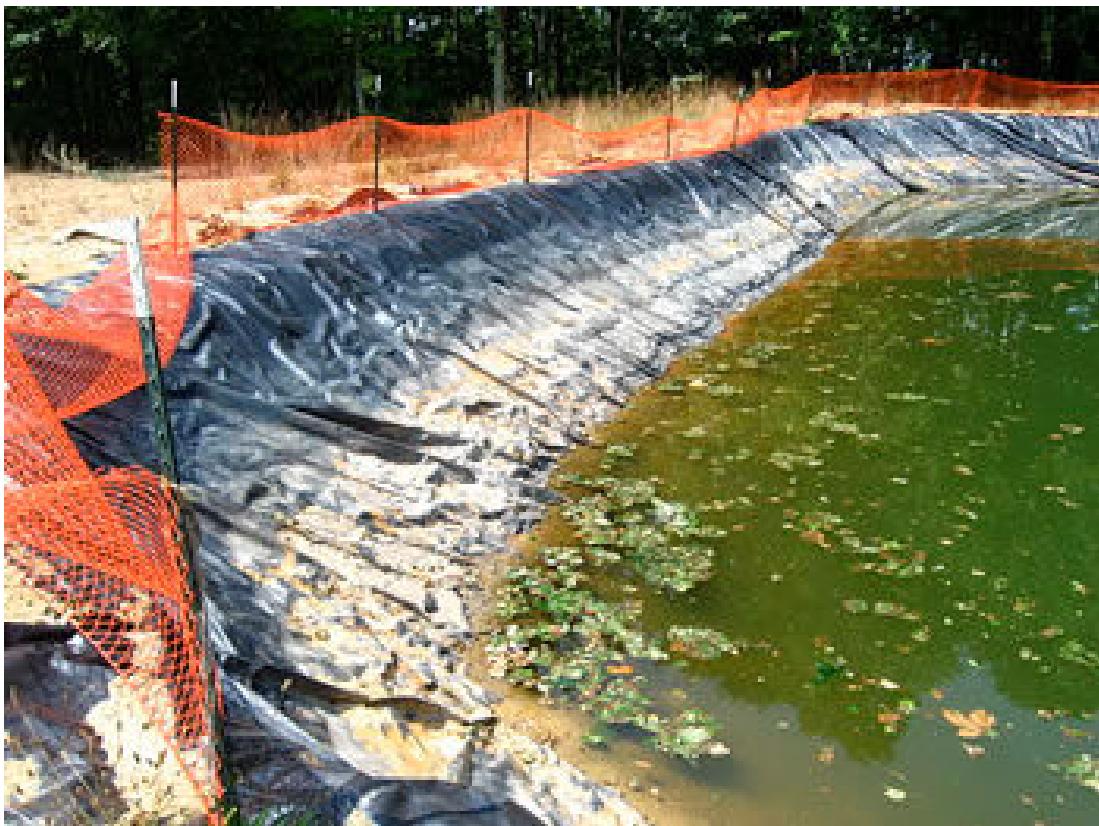
Large partially filled impoundment at 47-097-03716, a well plugged in May 2011. Besides this impoundment, there was also an open drill waste pit with torn liner. The plugged well's monument was improper and for some reason had a valved vent on top. The pad is almost bare of vegetation and a soil sample had a chloride concentration of 384 ppm. State law requires final reclamation of a plugged well's site within six months after plugging. Photo taken on 1 July 2012.

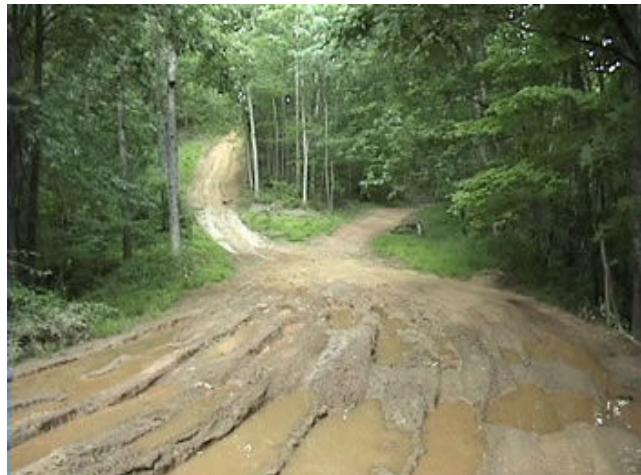
Photo 1. Long Road looking north. This is at A on the permit application drawing shown in photo 17. The steep grade on the left is about 30% and is an alternate route (red line on drawing). Pipeline right of way to the right is, at times, passable. This route wasn't useable by our ATV in 2012 though this is the access road shown on the drawing. The alternate route is always open for access. Photo from video shot on 7 June 2012.

a segment (because of the segment's length) with 3 to 5% grade.²² Drainage control is not shown on the sketch drawing and is in fact missing at the bottom of the steep grade just north of 47-079-00702 (see photo 1 and photo 17).

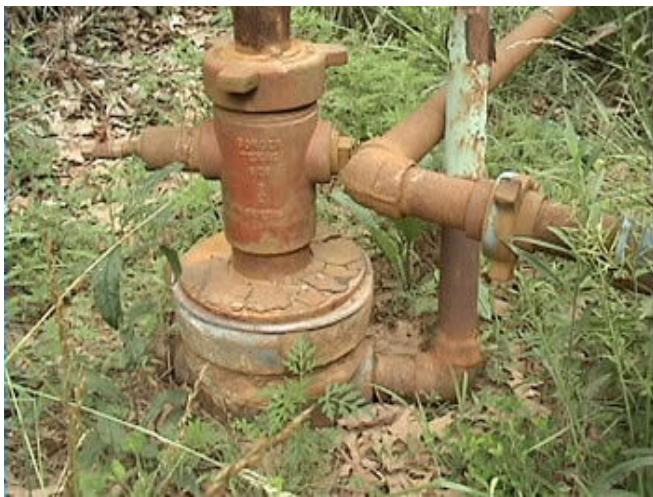
Photo 2. 47-079-00702 casing head with vent pipe on lower right hand side. Vent pipe (painted green) rises about 8 feet. Photo from video shot on 7 June 2012.

An older well, 47-079-00702, is in a low gap just above a small stream, about halfway between 47-079-01299 and 47-079-01314. The pad is bare of vegetation except around well equipment. This well is exceptional because it has a vent from the surface casing head to relieve pressure caused by inadequate casing and cementing of the well. Gases vent continuously from an open pipe end about eight feet above the ground.

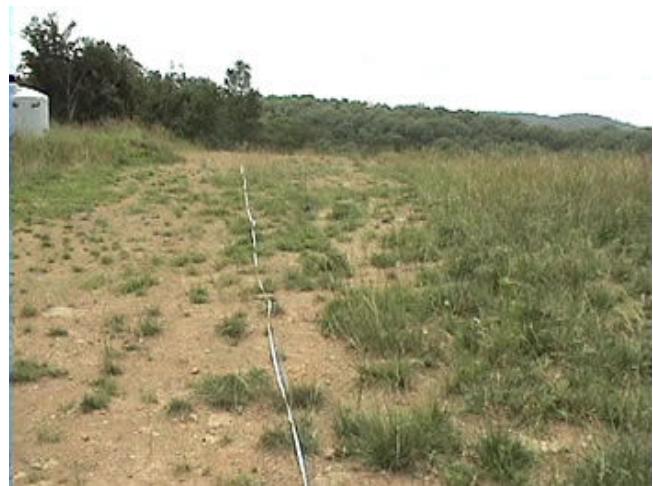
Photo 3. Barely vegetated pad for 47-079-01314. Tape measure follows line of exposed pit liner east of wellhead. See satellite photo of well site (photo 4) for comparison of location of pits in 2005. Photo from video shot on 7 June 2012.

On 47-079-01314's pad there is an 85-foot long line of outcroppings of pit liner apparently following the western edge of a pit shown in satellite photos of the well site. In 2010, at the northeastern end of this line of pit liner, we tested standing recent rainwater in what would have been the pit area and found a chloride concentration of 356 ppm. A soil sample collected nearby in 2012 had a chloride concentration of 536 ppm. Both soil and water samples were many times expected background levels for chloride and show persistent contamination of the site. Chloride doesn't naturally

remain in soil; it has the same mobility as water. High concentrations of chloride years after the well was drilled in 2005 points to contamination from buried pit waste rather than a one time spill.

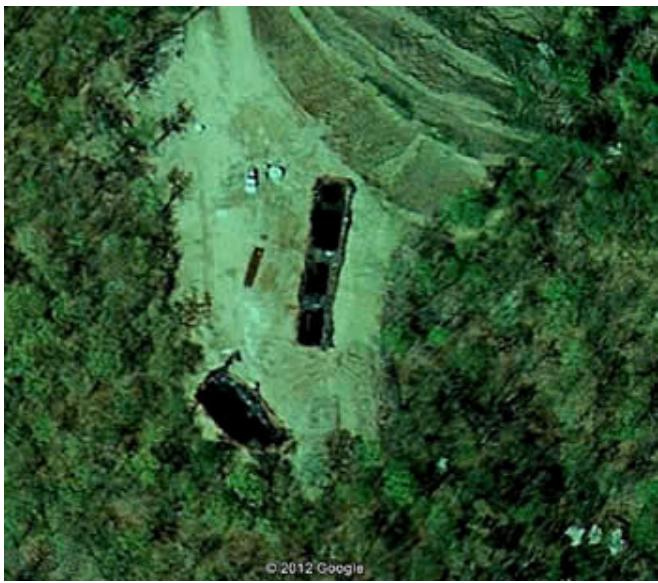
Photo 4. Satellite photo taken in 2005 of 47-079-01314. Line of exposed pit liner visible in 2012 is along western edge of large pit. Pieces of loose liner now lie on the surface near where the smaller pit is shown in the photo.

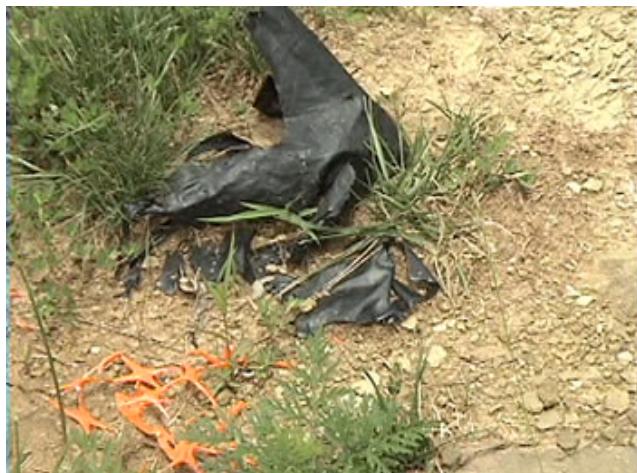
Photo 5. Large piece of exposed pit liner at 47-079-01314. Fragment of orange pit fencing is also visible. Photo from video shot on 7 June 2012.

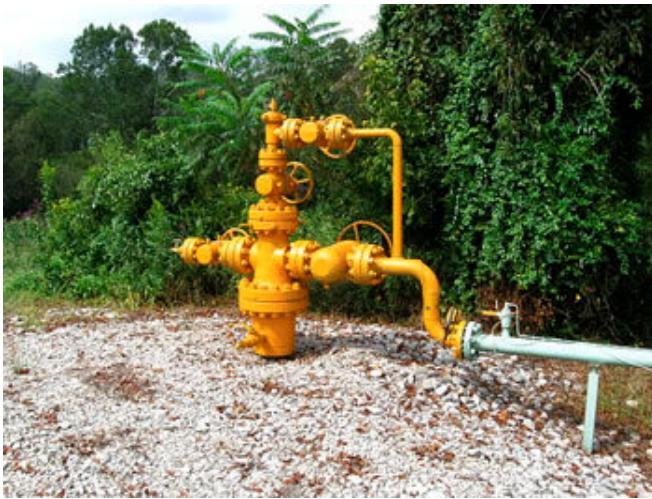
Photo 6. Wellhead for 47-039-01046 storage well, just north of Route 622, near Camp Virgil Tate. Photo taken on 6 September 2012.

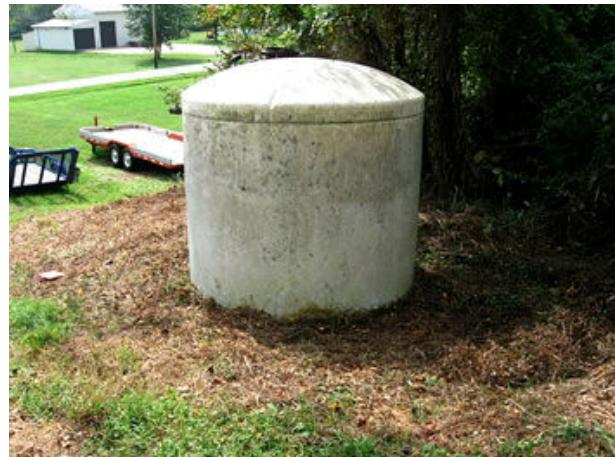
Photo 7. Large plastic condensate storage tank serving pipeline just north of Camp Virgil Tate Road. Tank doesn't have required secondary containment with rainwater drain. Pocatalico River is nearby to the south. Photo taken on 6 September 2012.

Three pipelines (two owned by operators and a third by Columbia Transmission) serving Columbia Transmission's Lanham Station are found along Camp Virgil Tate Road. At one point, where Cranberry Pipeline comes down the ridge toward the road, there's a condensate storage tank serving it.

⁹ The approximate location of the tank is UTM 17 437408E 4258665N. Secondary containment is required by 35CSR1.7 and 47CSR58.

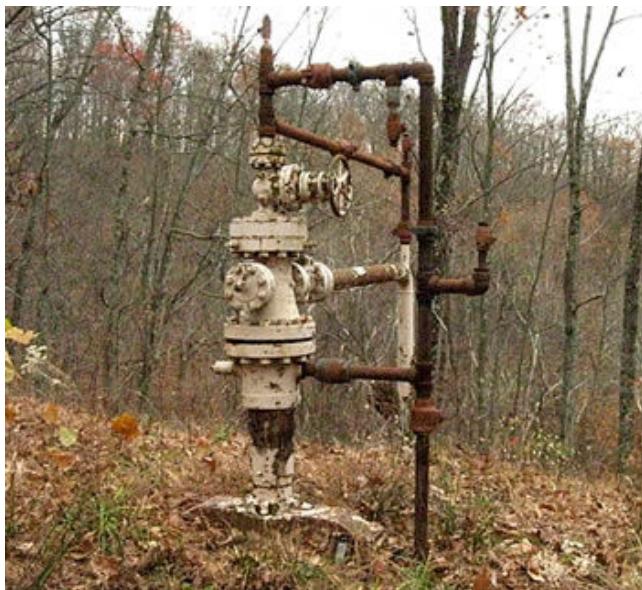
The first well, 47-039-01168, has been abandoned since 2005 with zero production being reported for 2007, 2008, 2009 and 2011. No production reports were filed for 2005, 2006 and 2010. The well, which lies next to a poorly maintained well access road, had no API number on the wellhead. The road appears to be too narrow for service trucks, such as a tender's or vac truck, though there was a condensate storage tank with proper containment. There was a small gas leak at or near the casing head.

Photo 8. Wellhead 47-039-01168 showing leaking oily fluid below flange on casing head. Audible gas leak was heard here. Photo taken on 12 November 2012.

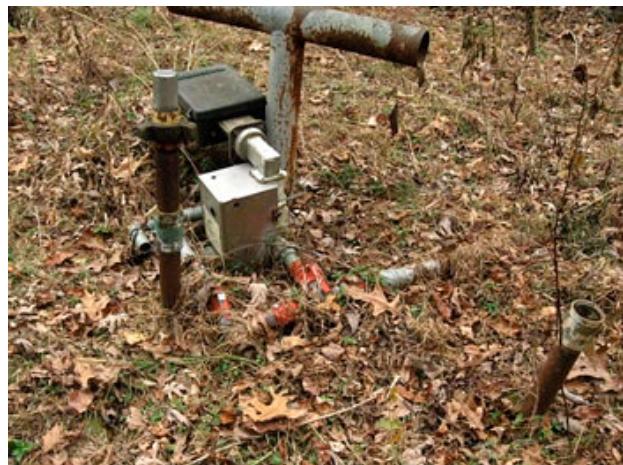
with API number. Just north of this monument we found equipment and pipe that had been abandoned. At first glance this appeared to be part of a pipeline along with a meter but pipes had been disconnected. If this served 47-039-02306 this material should have been removed as part of the final reclamation when the well was plugged.¹⁰

Photo 9. Disconnected pipe and meter just north of 47-039-02306 plugged well monument. Photo taken on 12 November 2012.

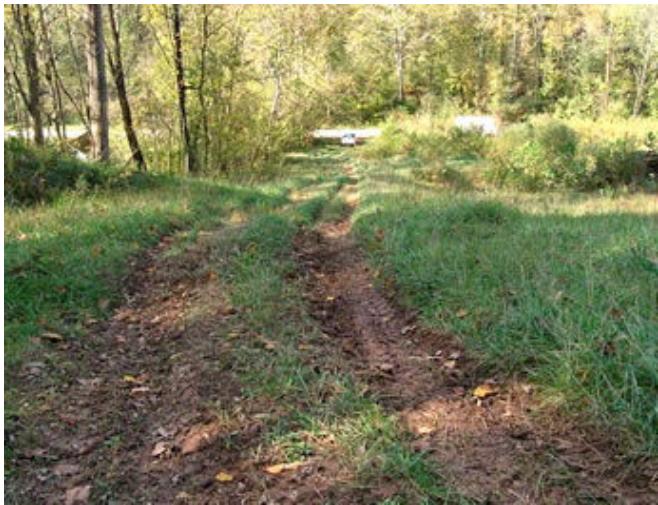
Photo 10. Steep grade for 47-079-01492 access road. Car is parked next to South Poca River Road. The Pocatalico River is just on the other side of paved road. Operator constructed a water bar part way up access road in 2009. This has not been maintained. Rain can wash sediment from access road directly into River. Photo taken on 12 October 2012.

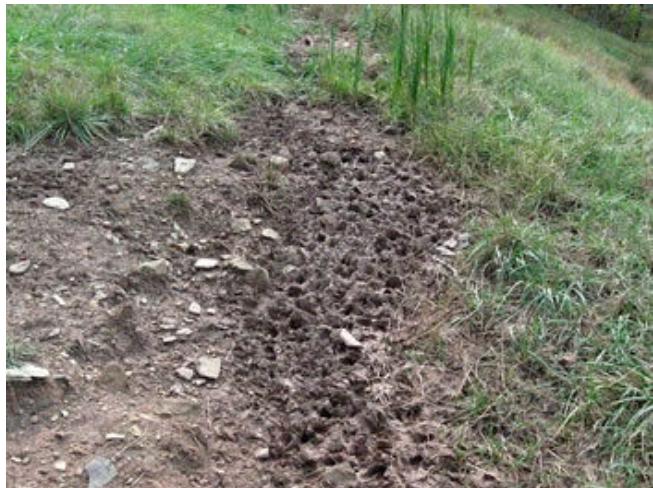
Photo 11. Extensive deer tracking on site of buried pit waste for 47-079-01492. Liner and waste exposed by recent slip is just to the left (south) of this picture. Photo taken on 12 October 2012.

deer tracks in a large bare area. This was near the locations where, in 2009, we'd found high chloride contamination of soil and stream water.

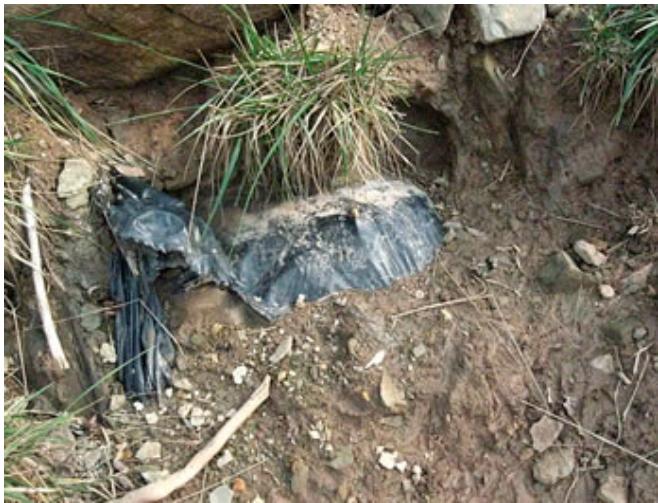
Photo 12. Buried liner and pit waste exposed in recent slip across pad of 47-079-01492. Photo taken on 12 October 2012.

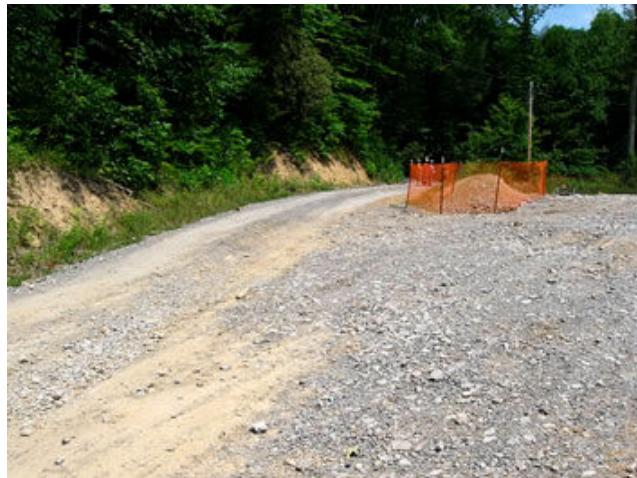
Photo 13. Paved state road is on the left and well access road is on right for the Tall Trees site (47-097-03707 and 47-097-03708 horizontal Marcellus wells). Damage to state road can be seen in picture. Photo taken on 1 July 2012.

A local resident talked about how large trucks had severely damaged the state road that the operator uses to access the site. According to the completion report for 47-097-03707 well work began in August 2010 (the permit was issued in February 2010).¹⁵ When we saw the site in early July 2012 the state road's pavement had buckled and collapsed in portions and was now repaired solely with gravel.

The resident described how part of the damage to the state road was caused by the large pad's drainage going onto the state road. A complaint had resulted in the company's construction of an armored drainage ditch along Route 20 to a culvert.

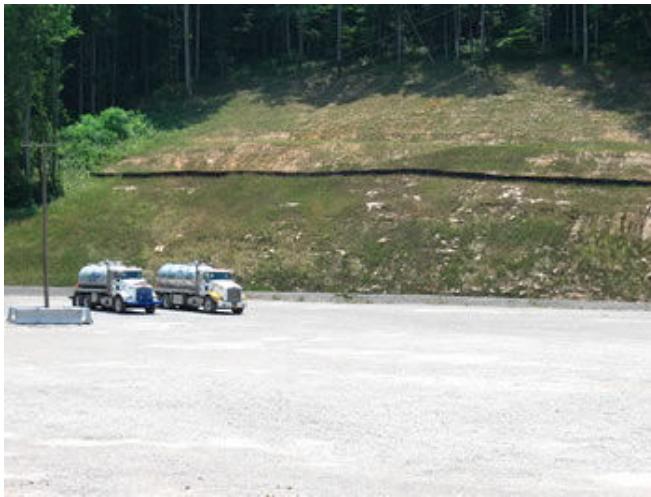
The Tall Trees site was examined from outside the pad's perimeter. This was only the second site we've seen over the years that had some sort of security fencing, in this case around the two wellheads and related equipment, for the public's protection. The pad was extremely large, completely graveled, with a gravel berm around part of the perimeter. A tall cut slope above the pad was inadequately grased and still had a silt fence across the upper portion.

Photo 14. Portion of large graveled pad at Tall Trees site (47-097-03707 and 47-097-03708 horizontal Marcellus wells). Steep cut slope is not adequately grassed. Two vac trucks at left in photo were waiting while another was removing condensate from one of the large storage tanks on the site. We were told that the tanks were emptied daily. Photo taken on 1 July 2012.

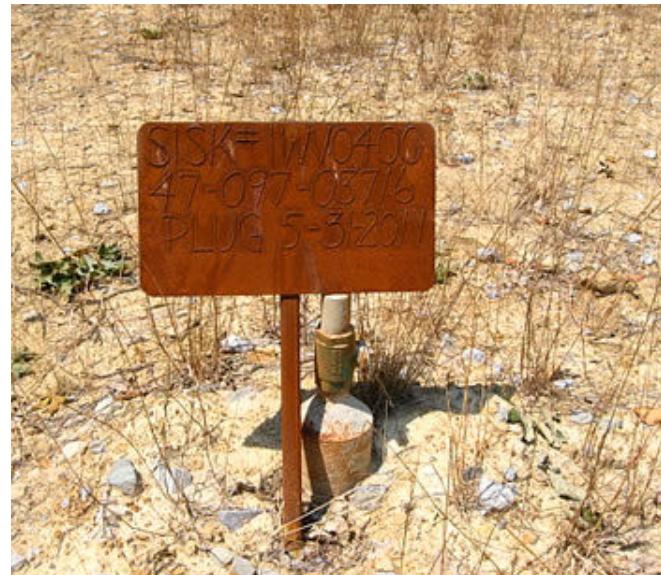
Photo 15. Improper monument for 47-097-03716, plugged in May 2011. Casing behind monument has smaller pipe set in cement with a closed vent on top. It's not clear why a plugged well would need a vent. Photo taken on 1 July 2012.

plugged in May 2011 according to the operator's inappropriate monument. The site was bare of vegetation. There were two open pits -- a large impoundment partially filled with water whose fence was down on one corner and another smaller, almost empty drill waste pit with badly torn liner (this pit's fence was entirely down). A soil sample was taken from a spot on the pad that had a slightly different looking soil. Chloride in the sample was 384 ppm. Our guide described how when he visited the site during drilling there was fluid splashing and flowing everywhere. He showed us where still evident drainage from the site went down the hill toward the trout pond.

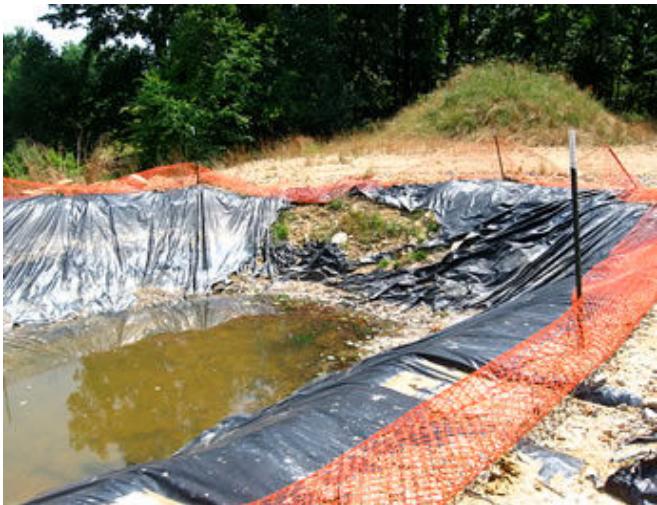
Photo 16. Smaller drill pit at 47-097-03716, a well plugged a year earlier. Liner is torn and fence is down even though cattle use field next to site. Pit appears to still retain fluid and cuttings. Photo taken on 1 July 2012.

plugging without reclamation; drill waste with apparent fluid/cuttings still remaining in the smaller pit which had torn liner allowing contamination of soil and groundwater; and an improper monument with a vent pipe. We have yet to receive an answer.

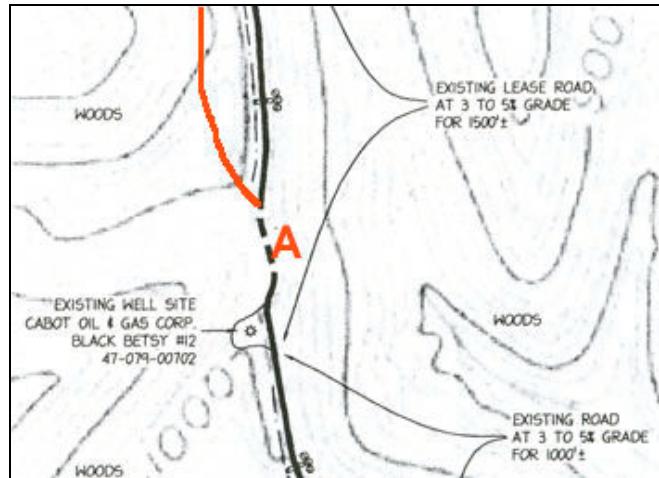
Photo 17. Part of permit application drawing for 47-079-01283, the access road constructed for 47-079-01314. The hatched road section is the location of the water filled ruts in photo 1. The red road segment on the drawing is the actual access road with a steep grade north of 47-079-00702. The route shown on the drawing is a pipeline right of way and is not always open for road access because of fallen trees or deep holes.

One of the things the drawings have to show is a road being constructed where no portion has more than 20% grade.²⁰ What this operator did, and other operators do, is measure road segments on the drawing so as to hide the fact there are steep grades. Segments are measured so that, on paper, enough relatively flat sections diminish the steep grades after determining average grade. Recommended practice in measuring grades is 50 foot or similarly short increments.²¹ In this permit application the increments are as long as 1500 feet. This helps hide the long steep road grades found on the Long Road, about 30% in sections, such as just north of 47-079-00702 which lies next to the access road about halfway between 47-079-01299 and 47-079-01314. On the application this portion of the road is part of

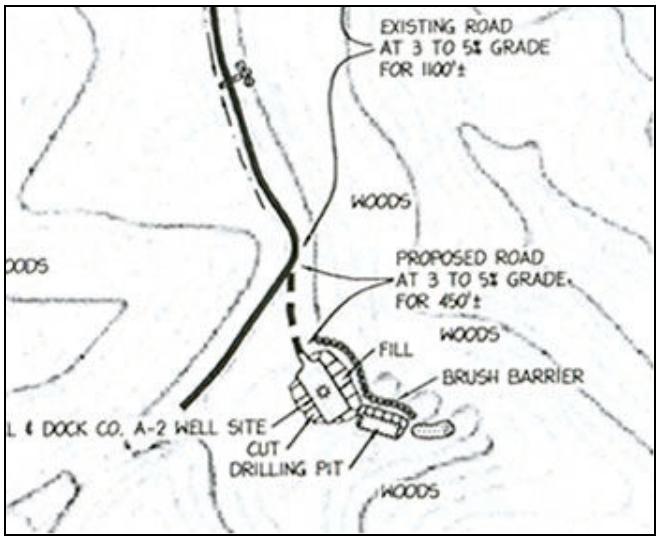
Photo 18. Part of drawing submitted for 47-079-01283 permit application showing sketch plan of well site, pit and sediment control. Another well was instead drilled nearby in almost the same location (47-079-01314). Compare this drawing with satellite photo of drilled well site in 2005 (photo 4). Hatched portion of access road is shown in photo 19.

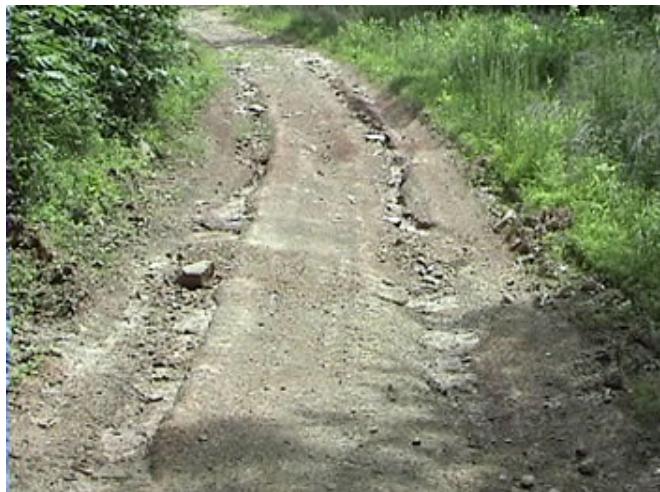
Photo 19. Well access spur from Long Road to 47-079-01314. Deeply rutted, the road's side ditches are filled with sediment. Photo from video shot on 7 June 2012.

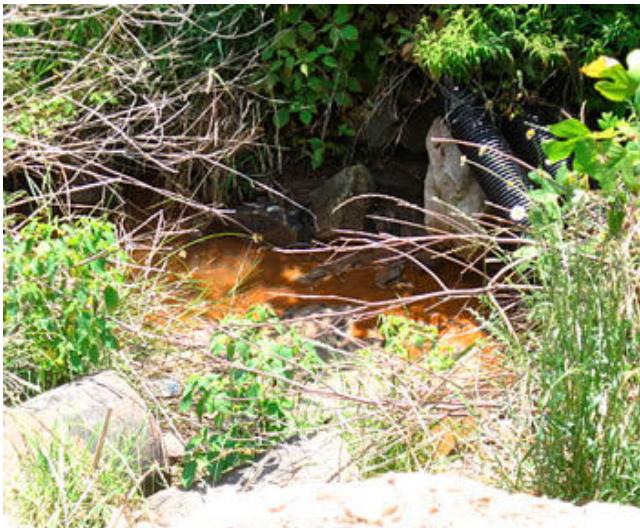
This ditch construction was recent and bare soil was lightly covered with straw. There was no sediment barrier at the end of the ditch where water entered a large culvert that leads to the Little Kanawha River. Standing water in the culvert's sediment trap was bright orange.

Photo 20. Sediment basin for culvert (not visible to the right). Photo was taken while standing on edge of newly constructed drainage ditch for the Tall Trees pad (47-097-03707 and 47-097-03708 horizontal Marcellus wells). Plastic pipes appear to carry drainage from cut slope to culvert. Photo taken on 1 July 2012.

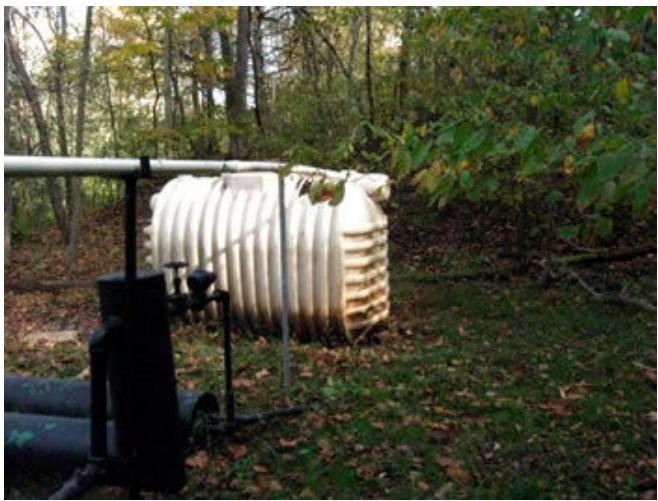
Photo 21. Condensate storage tank without secondary containment at 47-079-00615. This abandoned well lies just above South Poca River Road and is a short distance from the Pocatalico River. Photo taken on 12 October 2012.

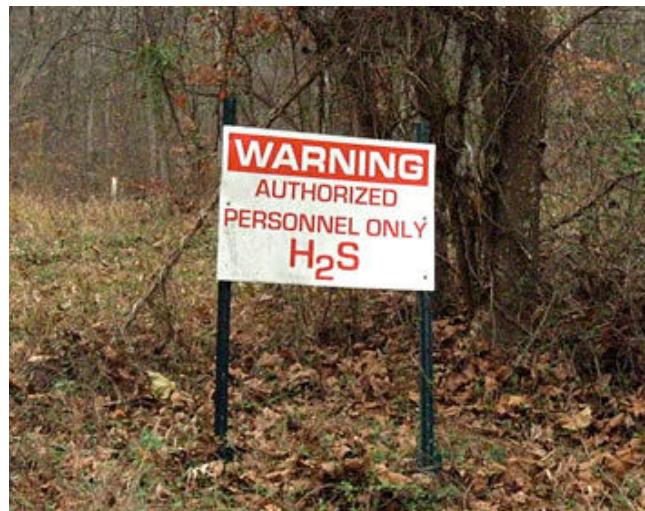
Photo 22. One of two hydrogen sulfide (a gas that can be deadly) warning signs left near plugged well 47-039-02319. Photo taken on 12 November 2012.

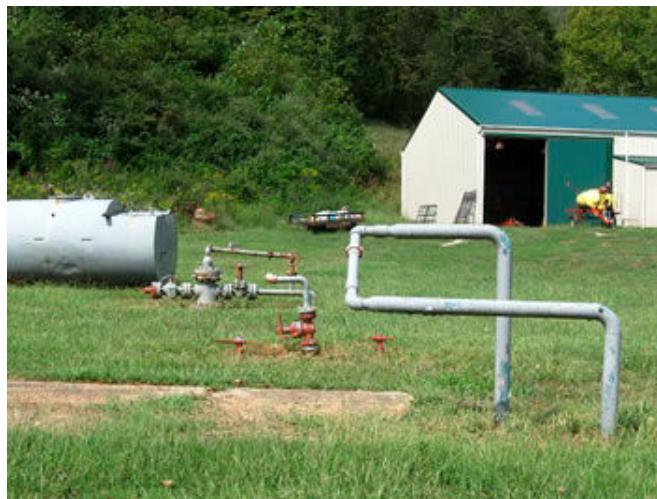
Photo 23. Well, 47-039-02204, on north side of Camp Virgil Tate Road near a large outbuilding. Tank to left and behind well appears not to be used. Photo taken on 6 September 2012.

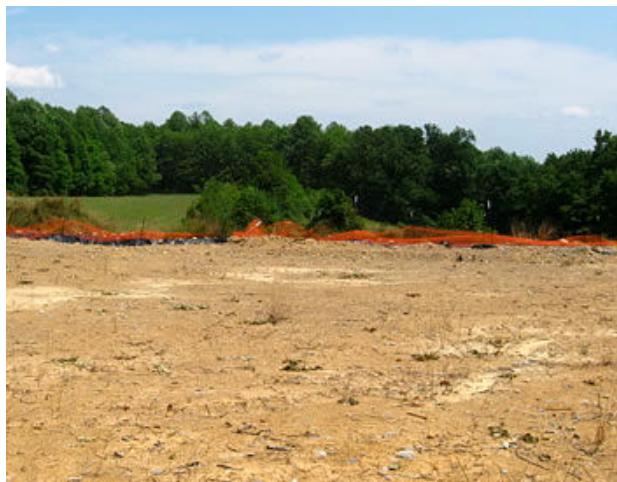
Photo 24. Pad bare of vegetation at 47-097-03716, plugged a year earlier. A soil sample collected at one of the lighter colored patches on the pad had chloride at 384 ppm. Photo taken on 1 July 2012.
