# **Environmental Assessment for 47-079-00731 and 47-079-01492, Putnam County, West Virginia**

George Monk and Molly Schaffnit  
Poca, West Virginia  
December 2009

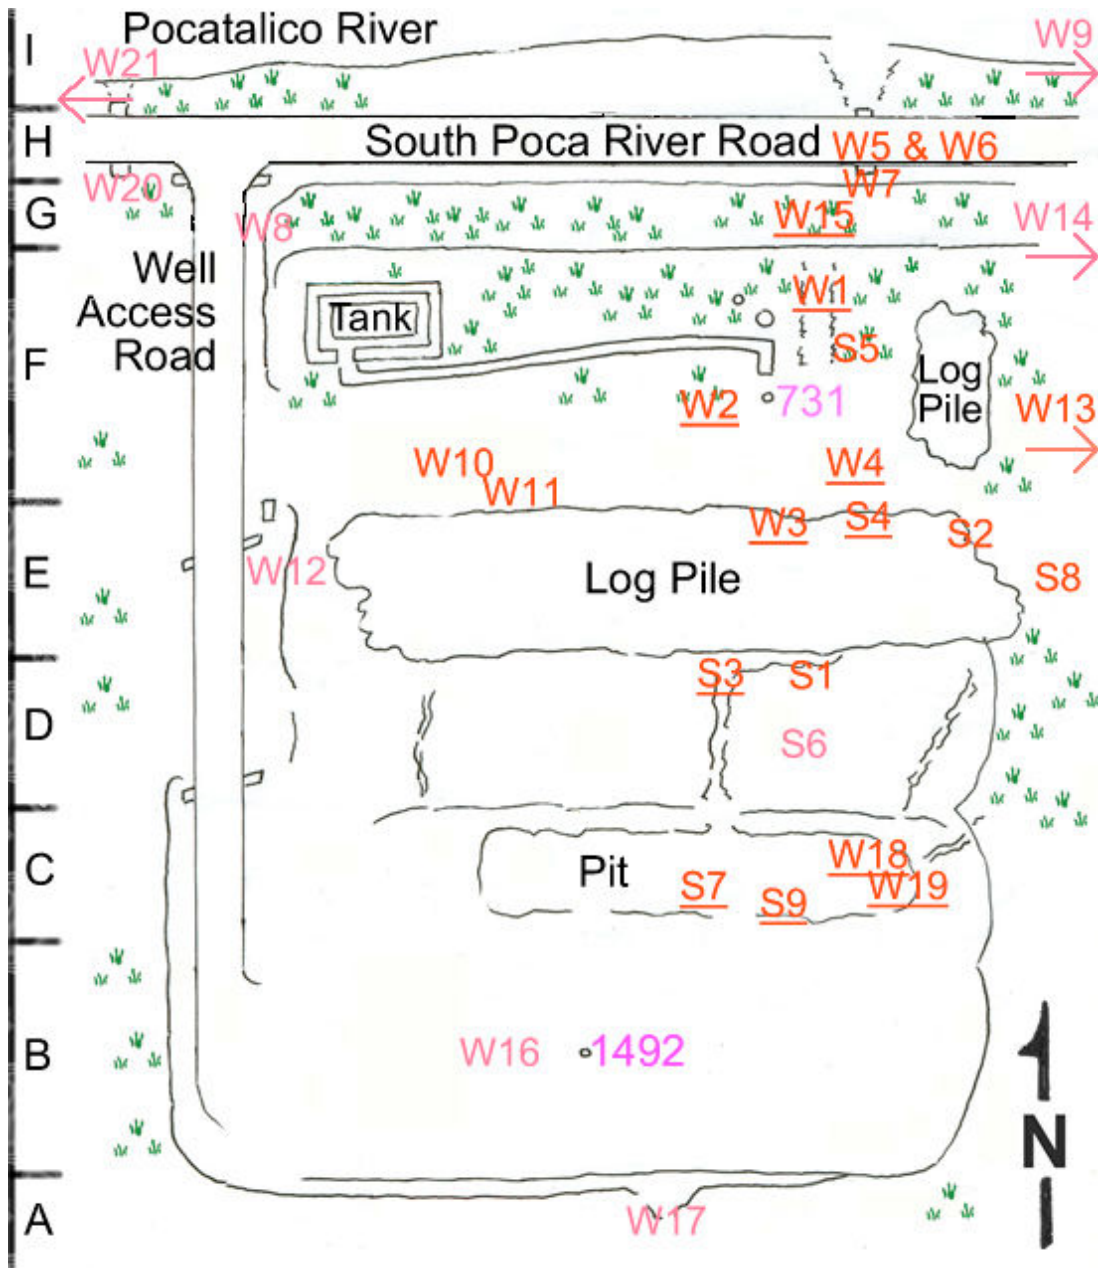
Map 3. Sample locations for water (W samples) and soil (S samples). Light red sample locations were less than 30 mg/l chloride concentration. Underlined dark red sample locations were above 300 mg/l chloride concentration. Zones are indicated in the left margin.

Testing showed a clear line of pollution from the pit, down the fill slope, through the log pile, past well 731, and onto the bench below. At each point a sample tested for chloride above 500 mg/l, many samples found much higher concentration.

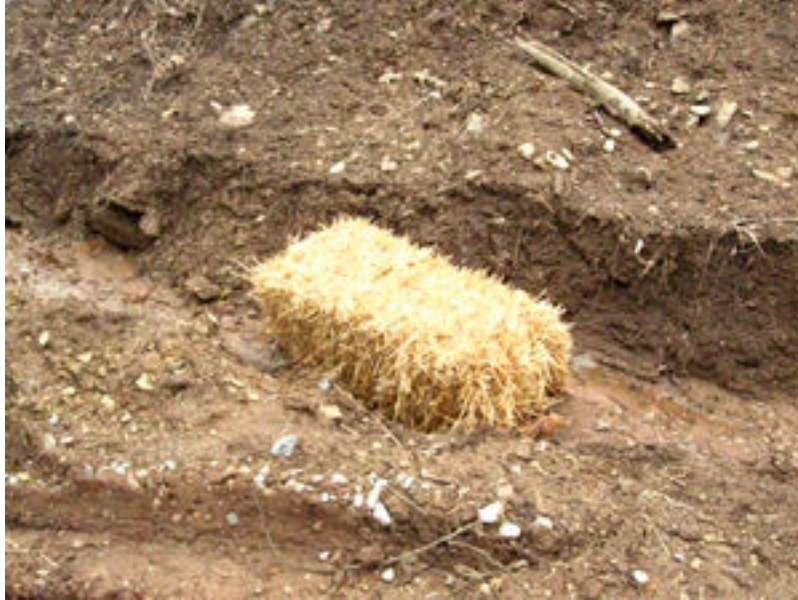
Photograph 1. Sedimentation control at this site was either lacking or insufficient. Sedimentation control structures were renewed between 12 January 2009 and 26 February 2009. This straw bale was improperly placed at this time.

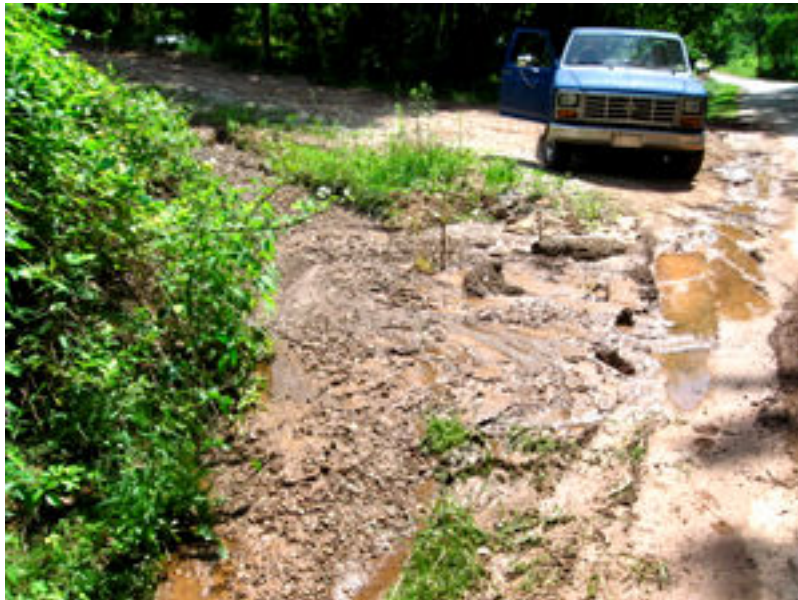
A much smaller culvert is under the site's access road connecting the ditches to the western culvert. This road culvert had been entirely blocked with sediment since January 2009 forcing water onto the road where it flowed toward the western culvert or across the road to the river.

Photograph 2. The truck in the background is sitting on the well access road entrance. A culvert under the access road directs water to the western culvert. On 27 November 2008 the culvert was nearly plugged with sediment. When sediment structures were renewed in early 2009, three straw bales were placed in the sediment trap. When this photograph was taken, the sediment trap has been completely plugged and the tops of the straw bales are barely visible in the middle of the photograph. Water can be seen running in the road toward the western culvert.

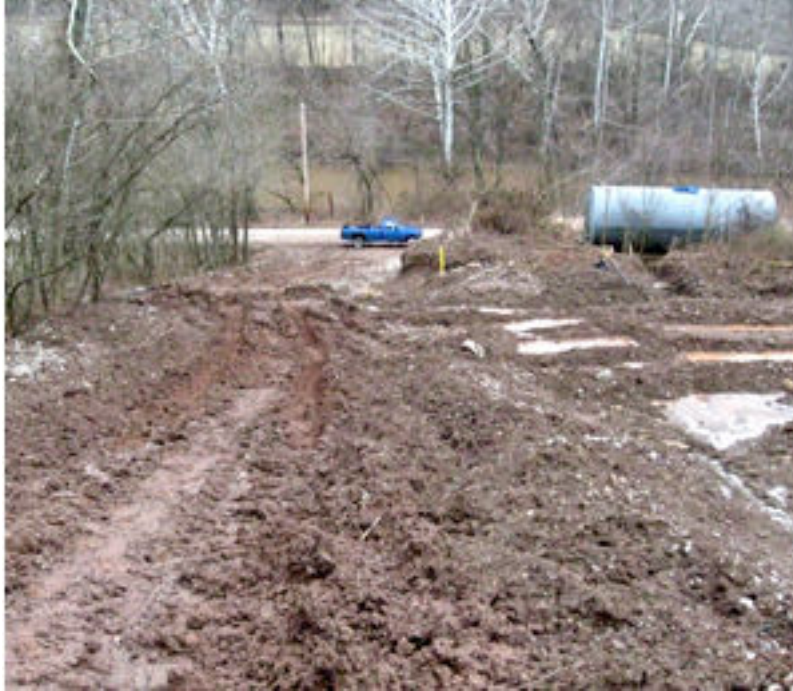
The trench through the dike for the large tank would serve as a conduit for condensate if the tank ever leaked. Condensate would then leave the site, just as surface water does, through the short wide ditch, onto the bench and

An important drainage feature is the well access road for 1492 and 731 which climbs straight up the hillside (27% grade) from the paved road. Only a short portion, at the entrance, had gravel. The operator, because of a complaint by a neighboring homeowner, put in a water bar about halfway up the access road before our visit on 12 January 2009. In June 2009 the water bar had been cut by tires and equipment treads so that it was no longer working effectively.

Photograph 3. This photograph was taken looking north down the well access road. The blue truck is parked by South Poca River Road and the large blue condensate storage tank is to the right. The trench through the tank's secondary containment is visible. The water bar constructed on the access road is in the middle of the photo.

It was obvious during all our visits that sediment was washing down this road onto and across the paved road. A silt fence between the river and the paved road should have been employed. A better drainage feature than a water bar for the well access road would have been a graveled broad based dip.

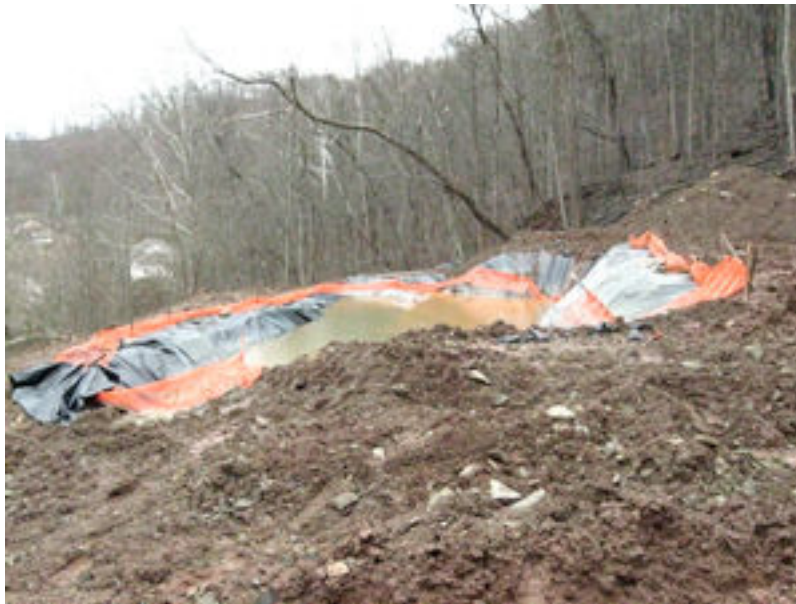
In January 2009 we noticed that the pit, located above the fill slope, had begun to slip, cutting that portion of the pad into what are now zones B (the pad) and C (part of the pit). In June 2009 we were able to verify that water was entering the pit in Zone C and then draining down the fill slope. At this time a new ditch had been cut at the base of the slipped slope for the stream in Zone A and water from the stream's flow was not observed crossing the pad in Zone B.

Photograph 4. This is the drilling waste pit as seen on 12 January 2009, looking east. The extent of the slip is apparent. The black material is pit liner and the orange is fallen fencing. There is almost no freeboard at the northeast corner of the pit.

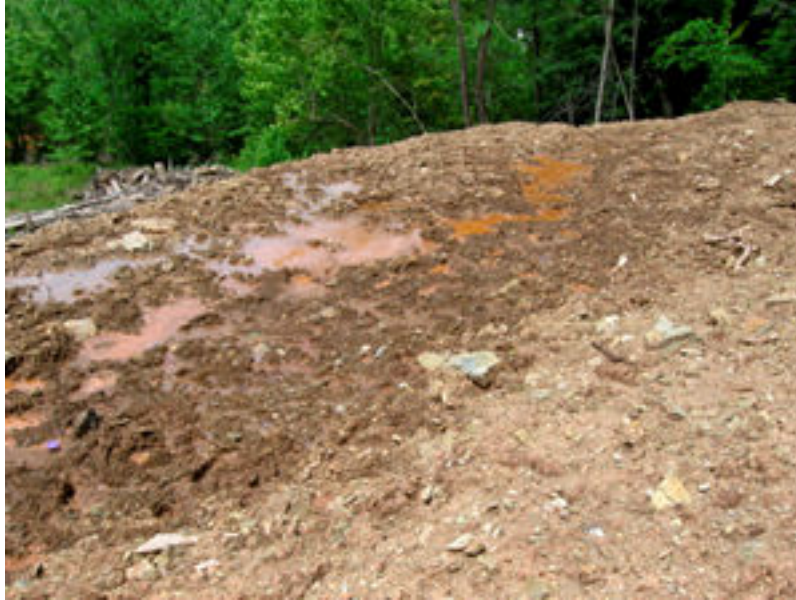
We believe the operator sited the pit on a spring or stream. In June 2009 we estimated the continuous flow leaving Zone C at its primary drainage point was half an inch in diameter or greater. Water also drained from the pit area at other points to the east. To repeat, we did not observe water crossing the pad to enter Zone C.

The appearance of the closed pit's surface in Zone C seems to indicate extremely shallow burial. We've seen a site operated by another company where part of the pit's contents were under only an inch or two soil cover. The piece of bent steel seen above the surface of 1492's closed pit may have been a rod used to hold the corners of the pit liner closed by piercing and pinning them.

Photograph 5. This is the closed pit, looking toward the northeast corner as in Photograph 4. Standing water is readily apparent. The main drainage point is to the left edge of this photograph. Secondary drainage points are to the east and northeast sides of the closed pit area.

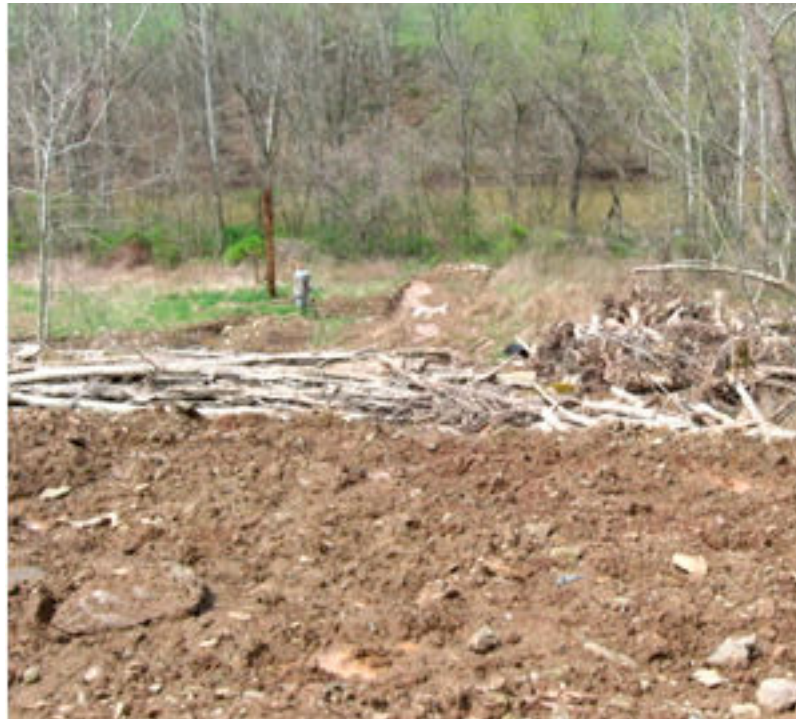
Photograph 6. This was taken looking north from the closed pit. The main and the smaller side log piles are visible, as is the separator for well 731. The drainage ditch to the east of the separator drains the flat that 731 sits on. The Pocatalico River is visible through the trees.

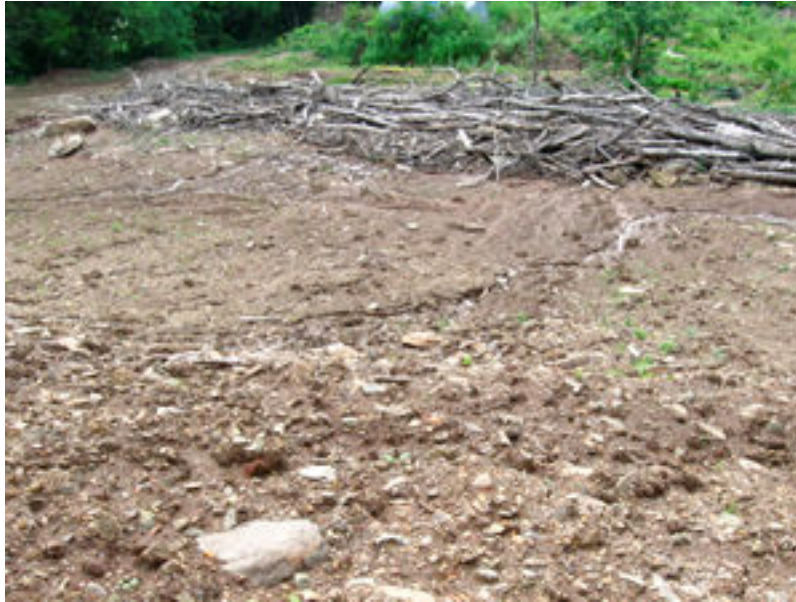
Drainage from the pit in Zone D on the fill slope again showed elevated chloride in samples S1 and S3 (285 and 513 mg/l respectively). A sample taken on the fill slope away from visible drainage from the pit (sample S6) showed <30 mg/l chloride.

Photograph 7. This was taken looking north down the fill slope below the closed pit. Drainage erosion is visible as well as liquid drainage closer to the log pile.

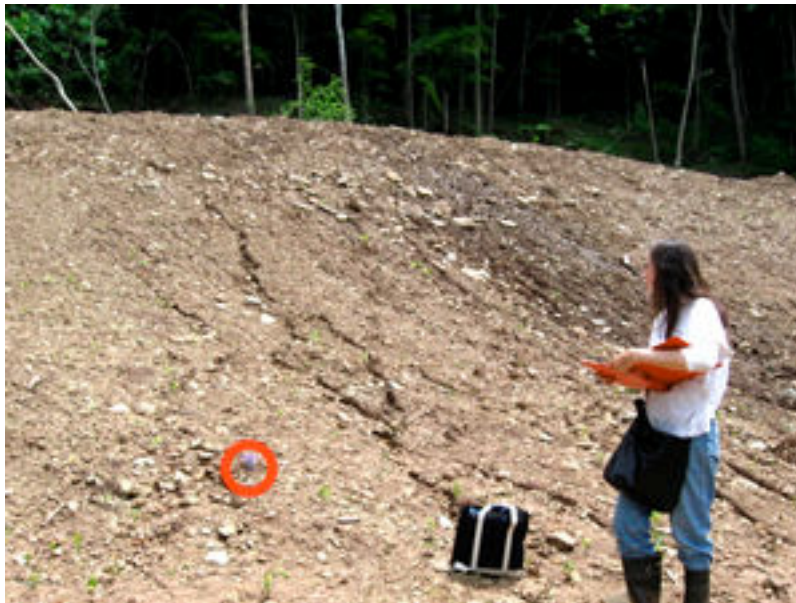
Photograph 8. This was taken looking up the fill slope. The main drainage for the closed pit is behind Molly. The red circle shows the location for sample S6, away from the drainage.

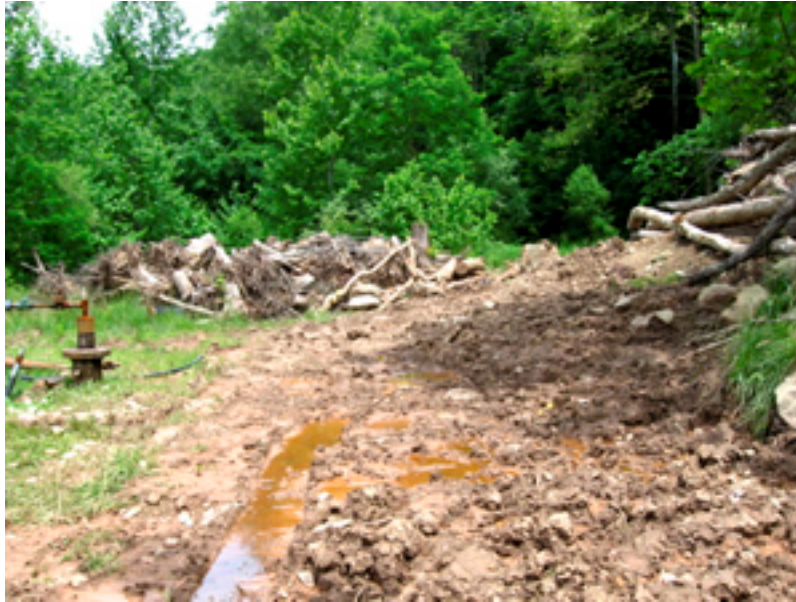
Photograph 9. This is the flat where 731 sits, looking east. The wellhead for 731 is visible to the left. The main log pile is to the right.

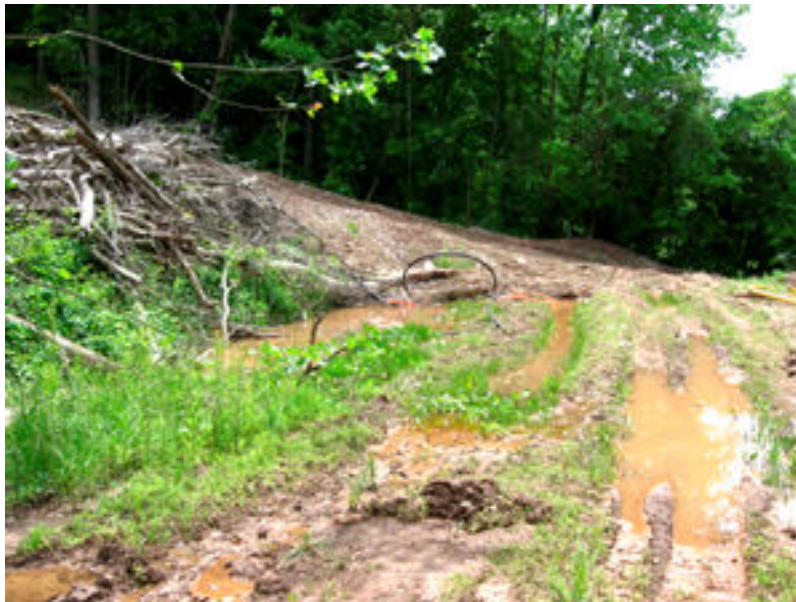
Photograph 10. This is same flat for 731, looking east. The access road angles upward toward 1492's pad. Large pools of standing water were between the log pile and the large condensate storage tank. We saw tadpoles here.

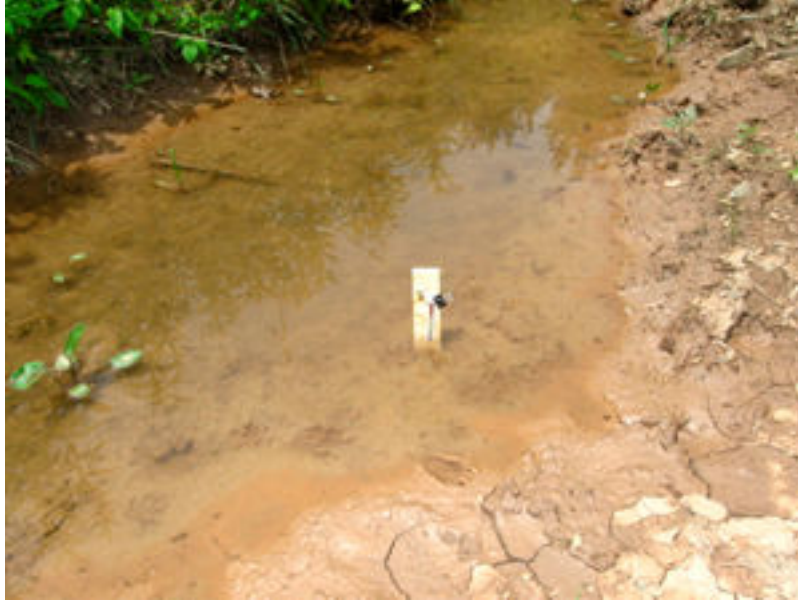
Photograph 11. This is the ditch to the east of 731, draining water from this flat area. A water test is being done (W1 595 mg/l chloride) using a Hach test strip clipped to a wood shim stuck in the mud. Deer tracks are evident in the foreground.

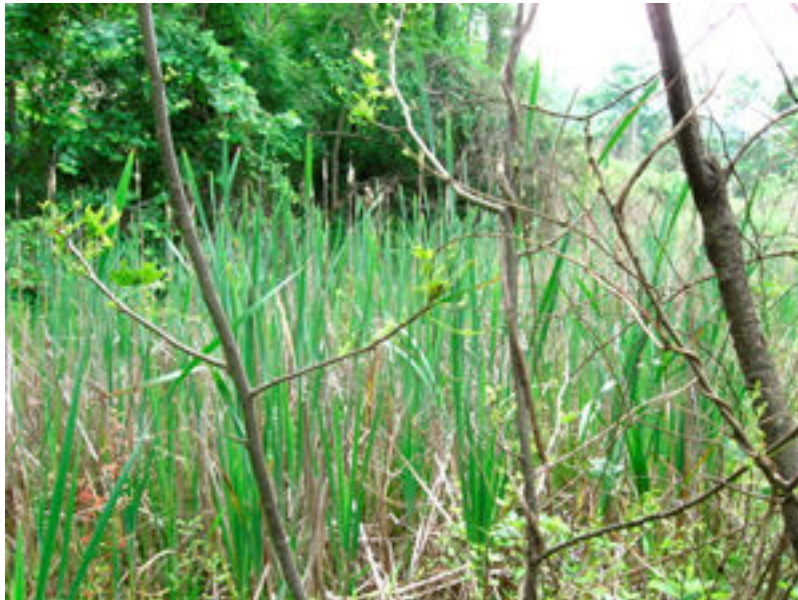
Photograph 12. To the east of the previous photograph's location is a wetland with a large stand of cattails.

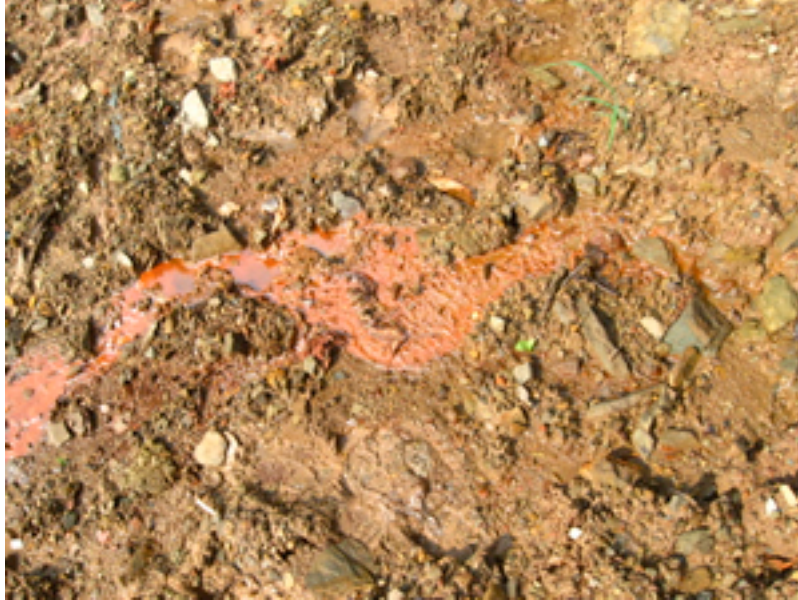
Photograph 13. Visible signs of pollution in the area of the closed pit included unnaturally colorful drainage.

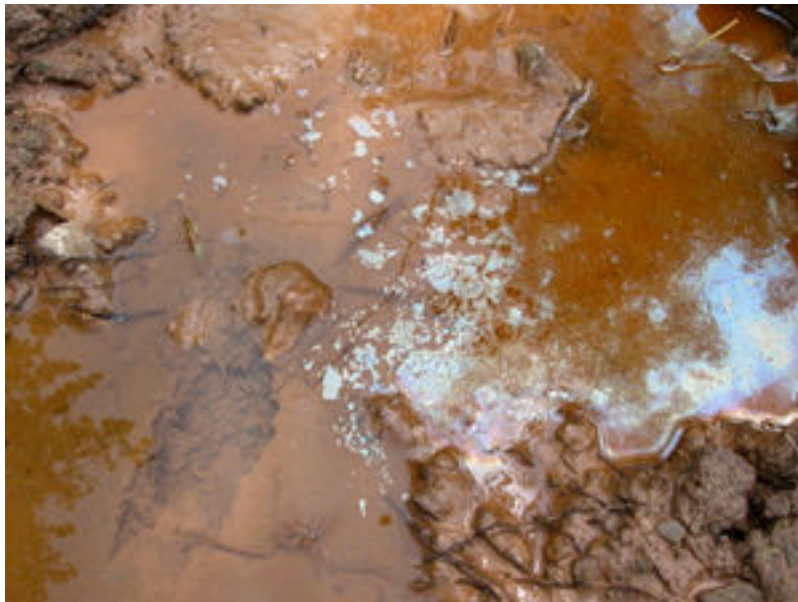
Photograph 14. This was taken of water ponding between 731 and the log pile. The iridescent sheen here is caused by iron-loving bacteria. Other sheen did not break up into blocks like this and was caused by oil.
