Site Visit – Storm Water Runoff Sample Collection
Hall Drilling, LLC – Tech Service Center
UIC Facility Permit No. 2D0859909
Lamberton, Richie County, WV
September 10, 2015 10:44-13:30

Field Narrative

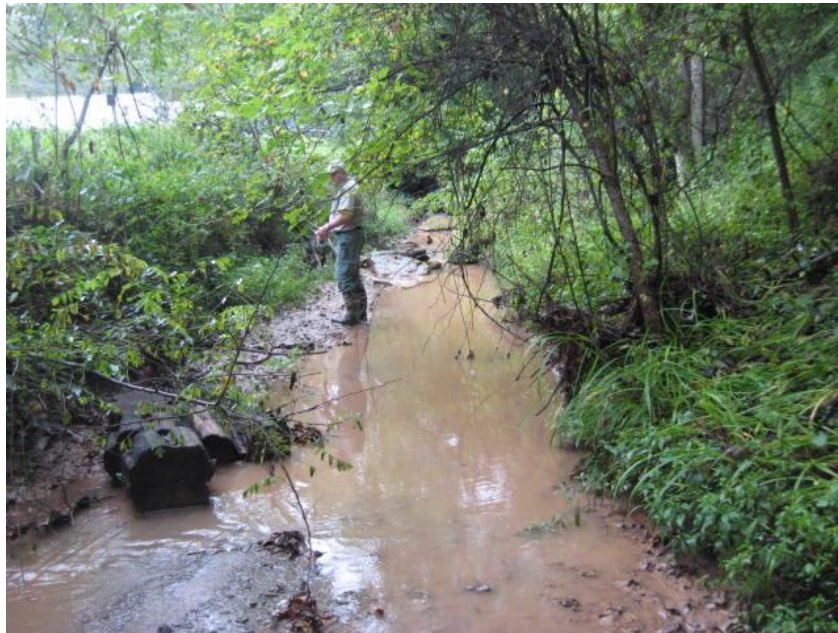
Sample locations were chosen so that the contributions of various tributaries to Hushers Run that drain the Hall facility could be assessed. Sample No. 1, No. 2, and No. 5 were located on the main stem of Hushers Run. Sample No.1 was collected

downstream of the tributary that drains the center of the Hall facility. The flow at this point was moderate with a milky and turbid character.

Hushers Run Sample Point No. 1 – Downstream of center tributary

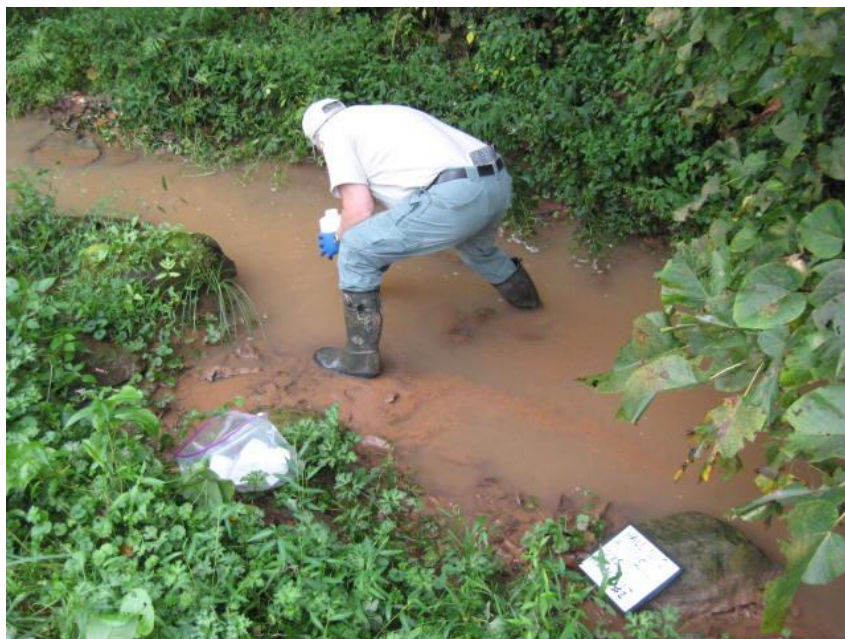
Sample No. 2 was collected downstream of the confluence of the tributary that drains the east side of the Hall facility. The flow at this point was also moderate with a milky and turbid character.

Hushers Run Sample Point No. 2 – Downstream of east tributary

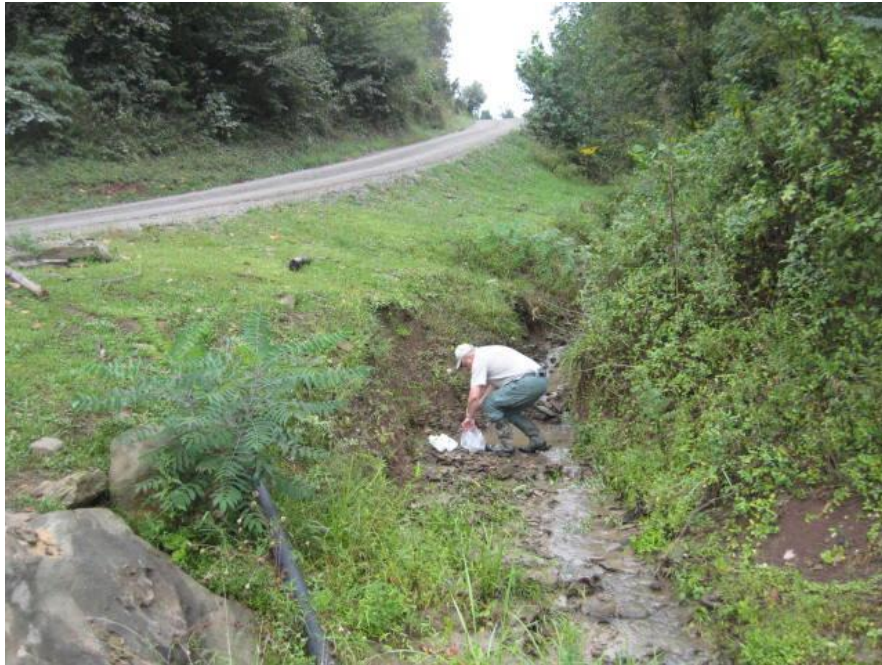
Sample No. 3 was collected from the center tributary just north of the guardhouse at the entrance to the Hall facility. The flow was moderate and was clear to slightly turbid.

Sample Point No. 3 – center tributary

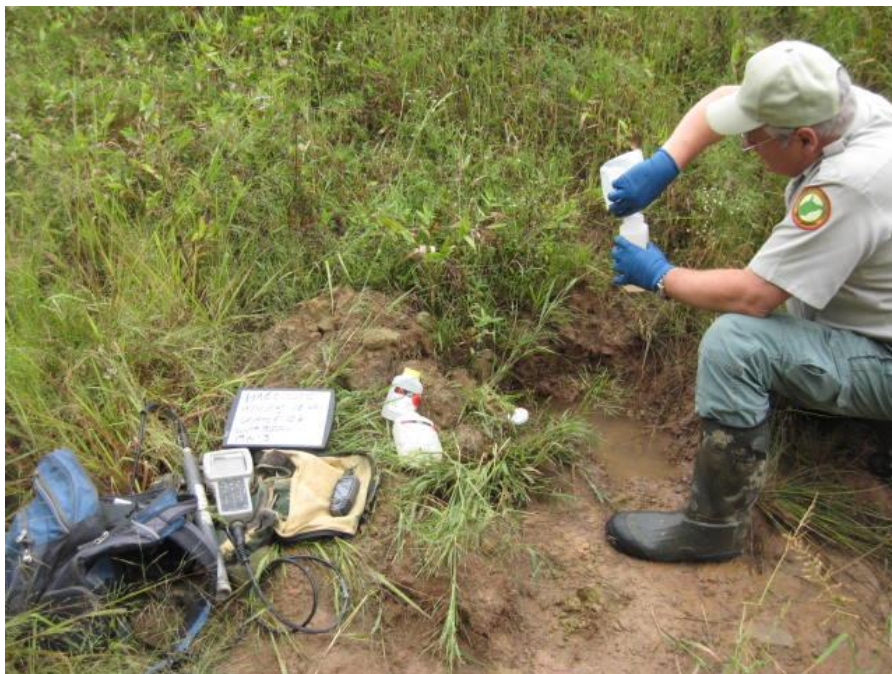
Sample No.4 was collected from a small seep approximately 50 feet east and downslope from Monitoring Well No.3 (MW-3) located at the west side of the west holding pit. During a previous site visit, a shallow sump was dug at the location of the seep in order to allow sufficient water to collect for sampling purposes. At the time of this visit, the sump was full and clear and recharged at a rapid rate after sample extraction.

Sample Point No.4 - Sump below Monitoring Well No.3

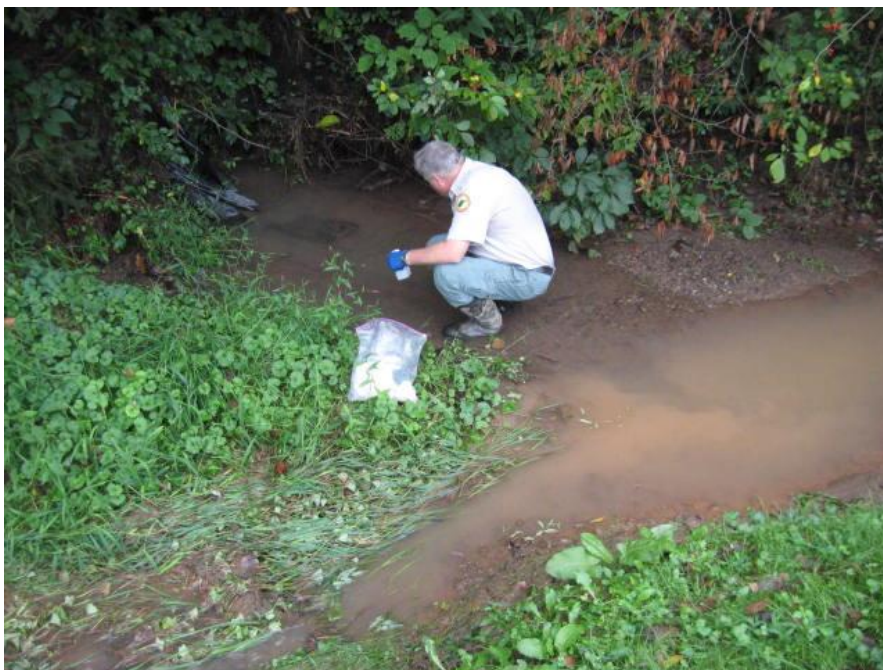
Sample No. 5 was collected upstream of the confluence of the east tributary that drains the east side of the complex. The flow upstream at this point was moderate and was clear to slightly turbid.

Hushers Run Sample Point No.5 – Upstream of east tributary

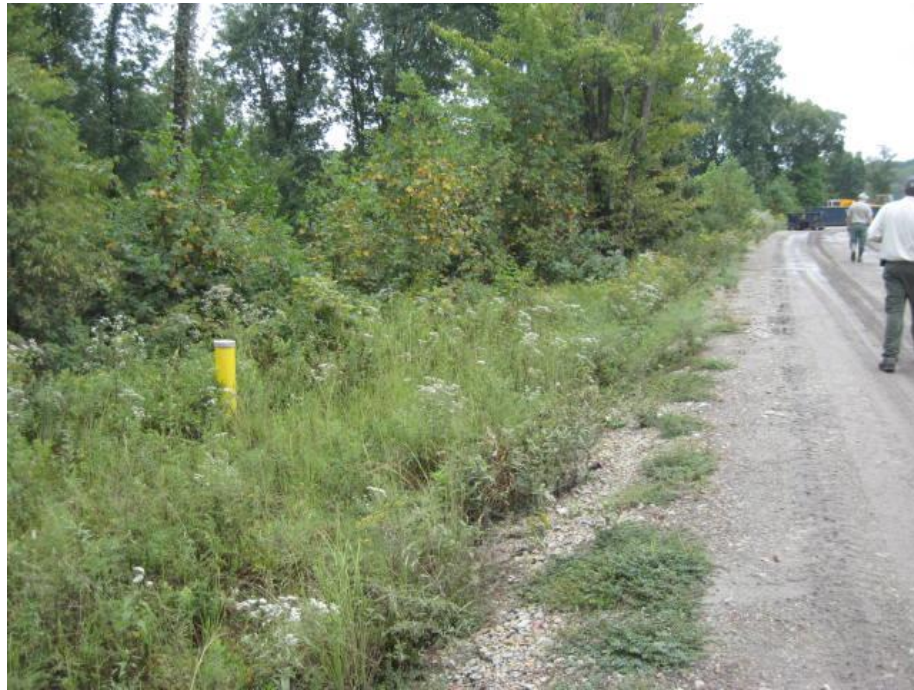
WVDEP personnel toured the site with Jason Hall, Manager of the facility. All three groundwater monitoring wells were in good condition with locked caps.

Monitoring Well No. 1 (facing south)

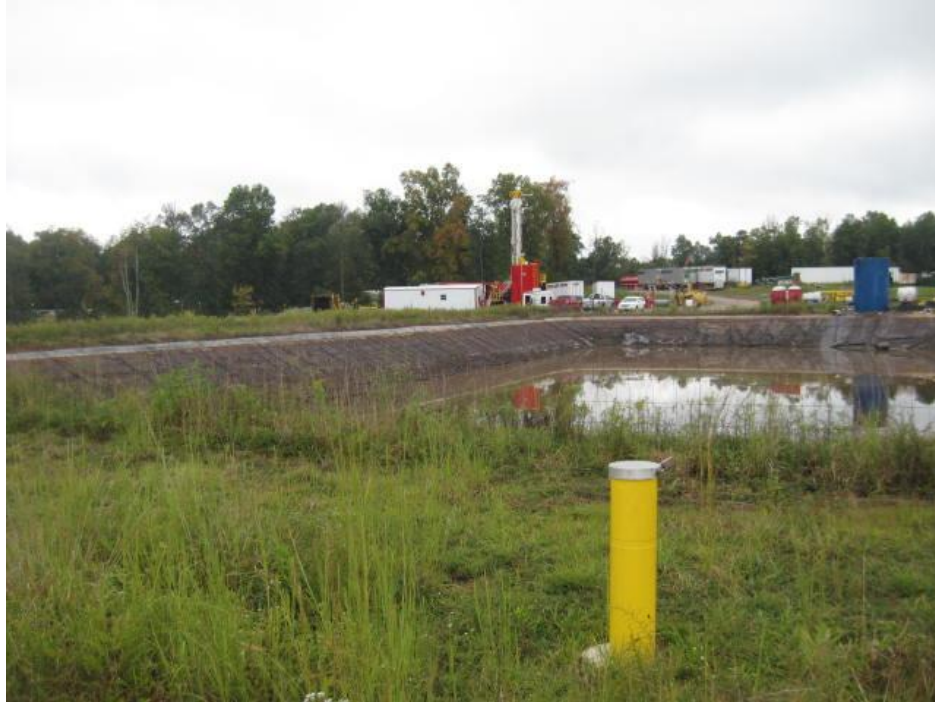
Monitoring Well No. 2 (facing northwest)

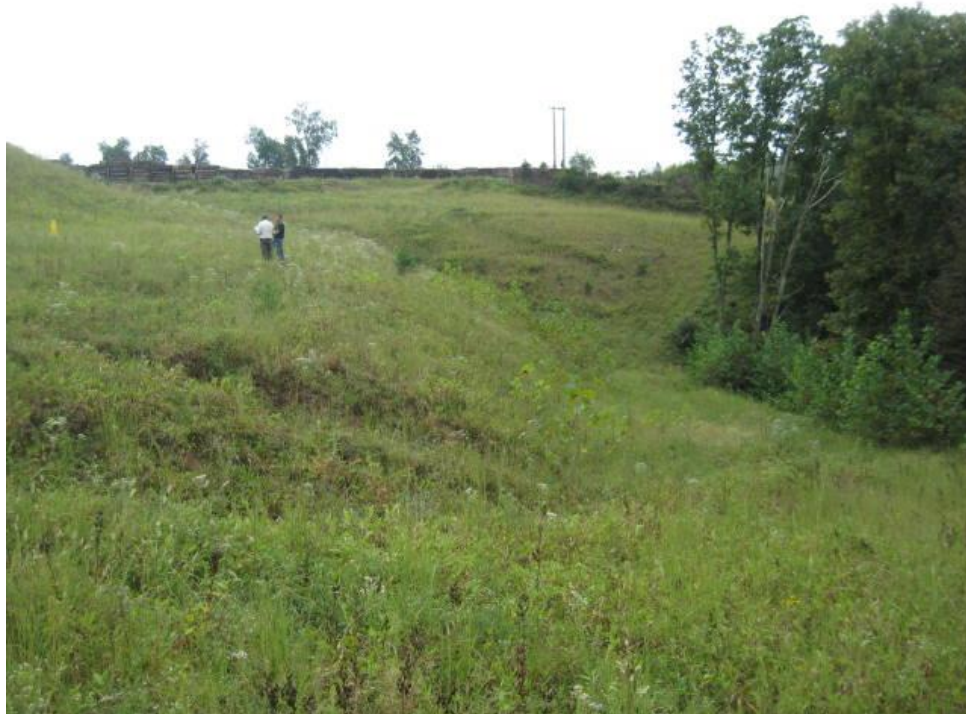
Monitoring Well No. 3 (at left, facing south)
