Environmental Assessment for 47-039-02026, Raymond City #6, Kanawha County, West Virginia

George Monk and Molly Schaffnit
Poca, West Virginia
June 2009

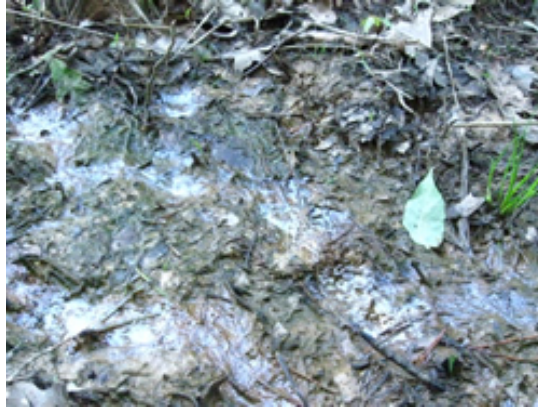
Photo 1. Oil sheen on mud in ditch behind tank.
Location of sample S8.

The contaminated ditch showed a lower concentration of chlorides (S8). When the soil sample was taken the petroleum contamination of the soil was still evident in the form of an oily sheen on the mud. This sample, after mixing with distilled water, had a strong condensate odor when the lid of the container was removed. The condensate odor never went away.

Nothing was done by the operator to mitigate the effects of contamination of the soil by the crude petroleum and brine spill of January 2008. While eventually petroleum hydrocarbons will be broken down by soil bacteria, it appears that this will take years to happen. A question here is whether the high chloride content of the soil inhibits these bacteria.

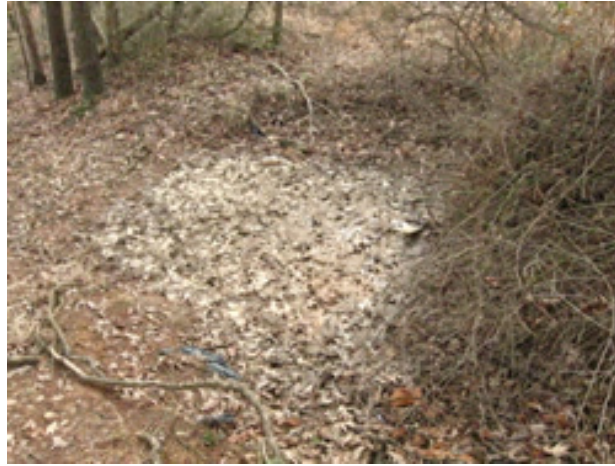
Photo 2. Photograph of notch taken in February 2009 showing extensive deer tracking.

What has happened to cause the soil at the notch to be contaminated is one of the questions we'll try to resolve in the future. Fragments of black plastic (pit liner?) seem to indicate that it might be a workover pit but we've been told by the Office of Oil and Gas that no permitted workover has taken place at this site. Soil here always shows signs of moisture, unlike most areas of the pad, and that raises other questions. Does soil contaminated with chlorides hold moisture better? Is there something happening at this spot so that fluids (either water or brine) from below the surface are appearing here?

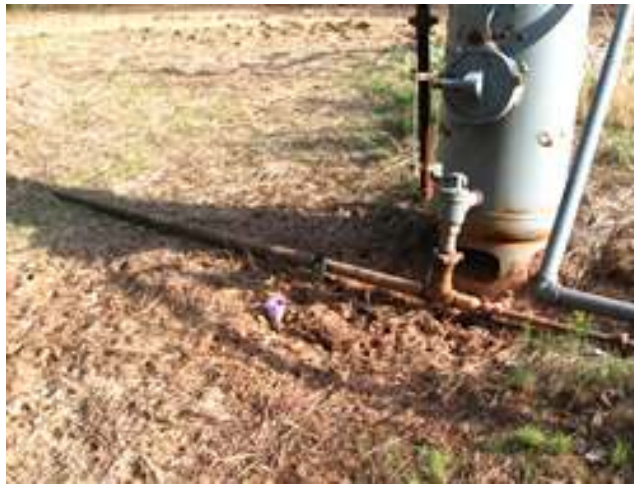
Photo 3. Pipe for oil and brine running from separator to tank (not shown). Great numbers of deer tracks along here to right up against separator.

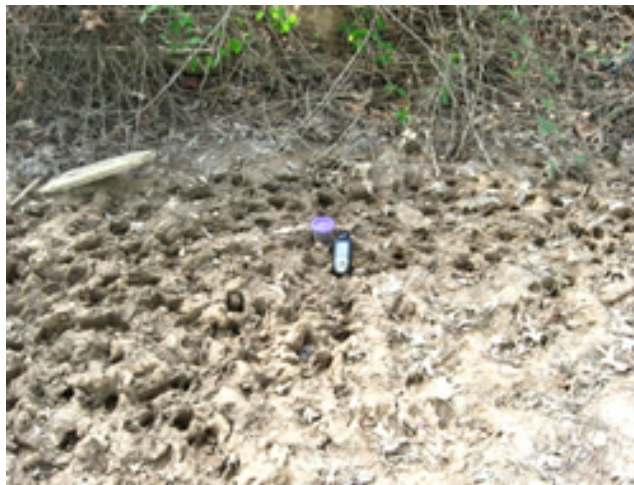
in January 2008 (42 mg/l). The notch (S2) and the separator (S3) locations showed evidence of unusual deer activity. High soil chlorides here seems to indicate that where we see high level deer tracking at other sites we can expect also to find elevated chlorides.

Photo 4. The notch with extensive deer tracking at time soil sample (S2) is being taken. GPS device is in center of photograph.

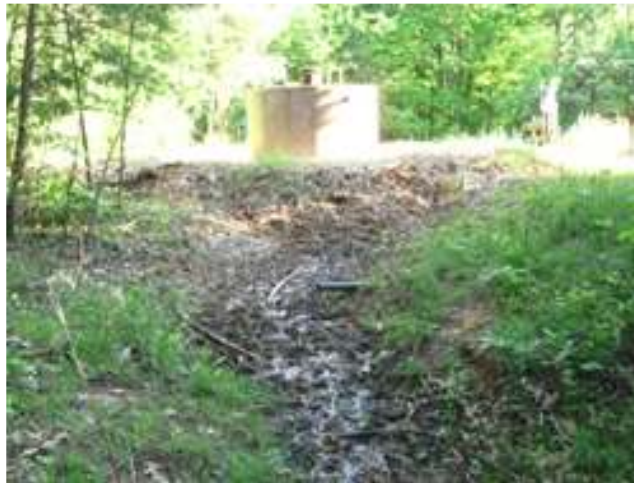
Photo 5. Ditch behind and below tank.
The ditch goes a short way down hillside.

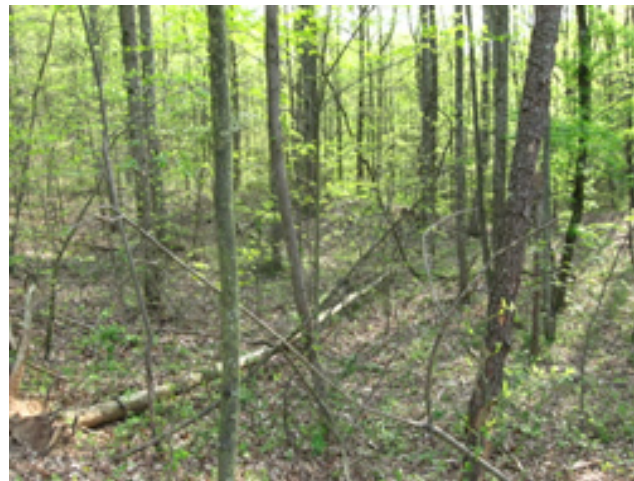
Testing didn't show one way or the other if the supposed pit was a drill waste pit or not. Chlorides would be expected but not necessarily high chlorides. At the same time, soil chlorides possibly would diminish over time in response to weathering.

Photo 6. This photo was taken in the supposed pit,
showing high bank. The bank appears
to be artificial.
