Environmental Assessment for 47-039-05714, Raymond City #11, Kanawha County, West Virginia

George Monk and Molly Schaffnit
Poca, West Virginia
November 2009

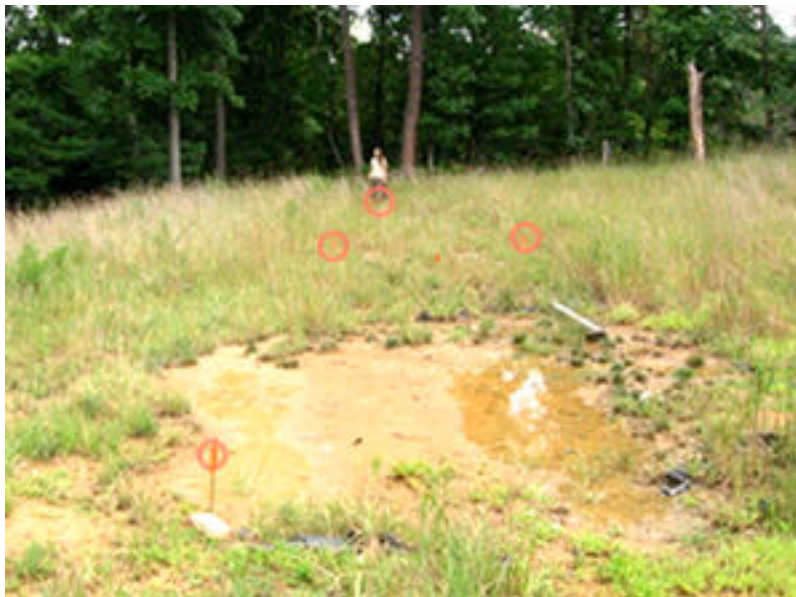
Photograph 1. View of the pit area showing perimeter of exposed black plastic (indicated by red circles). Molly is standing at easternmost edge of perimeter about 100 feet away. Sparsely vegetated area with highest chloride tests is in foreground. Photograph was taken looking east.

Exposed black plastic created a perimeter that was roughly 15 feet wide and 100 long. At the western end within this perimeter there was no vegetation at all. Vegetation became progressively less sparse towards the east.⁴ There was a portion of thick steel cable emerging from approximately the center of the space within the perimeter of exposed plastic.

The only soil locations that tested greater than a trace concentration of chloride were within the perimeter of exposed black plastic: the two initial soil tests S2 and S3 (>650 mg/l) and the later tests S5 (>650 mg/l), S6 (331 mg/l) and S7 (136 mg/l) along the traverse. One soil test, the easternmost sample on the traverse, S8, showed less than 30 mg/l (Quantab 0.6).

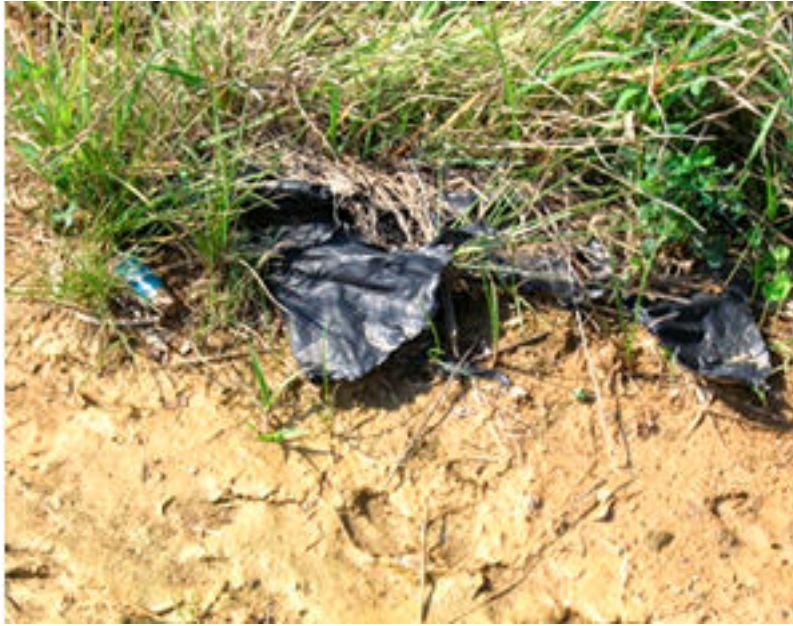
Photograph 2. Portion of exposed black plastic. Deer tracks are visible in foreground.

We noted deer hoof prints in the vicinity of the hot spot and believe that deer are attracted to this location because of the salts in the soil which they ingest.¹¹

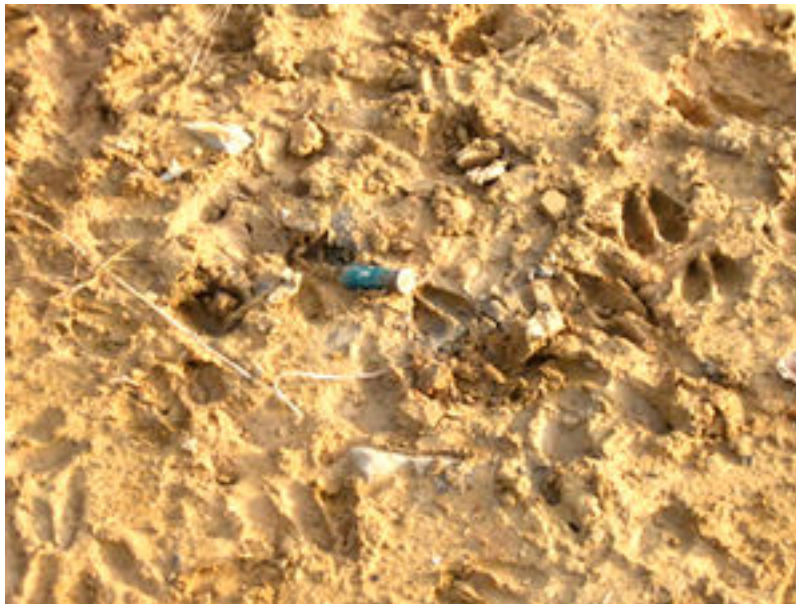
Photograph 3. Taken in October 2009, this photograph shows extensive deer activity at the location where samples S2, S3 and S5 were taken. The location for sample S5 and laboratory sample 5714-A is indicated by the green shotgun shell.

We collected two samples of the pit material on 6 August 2009 and sent one to Pace Analytical Laboratories for analysis. The sample submitted to Pace (5714-A) was collected at between 4 and 5 inches below the surface,

where the material appeared to be entirely pit waste by its color and consistency. The sample was collected exactly from the same location as S5.

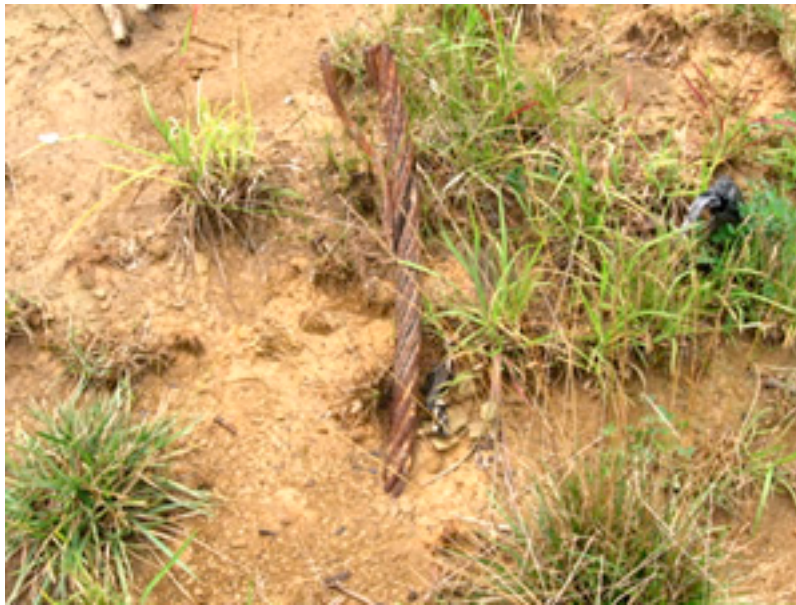
Photograph 4. Piece of steel cable emerging from surface. This is the approximate center of the perimeter of exposed black plastic and is the location of soil test S6.

⁶ We have assumed that this is close to the center of the closed pit. We believe the piece of steel cable was used to puncture and hold the folded ends of pit liner while the pit contents were buried. We observed a similar piece of steel projecting above the surface of the closed pit of 47-079-01492, a well operated by a different company.

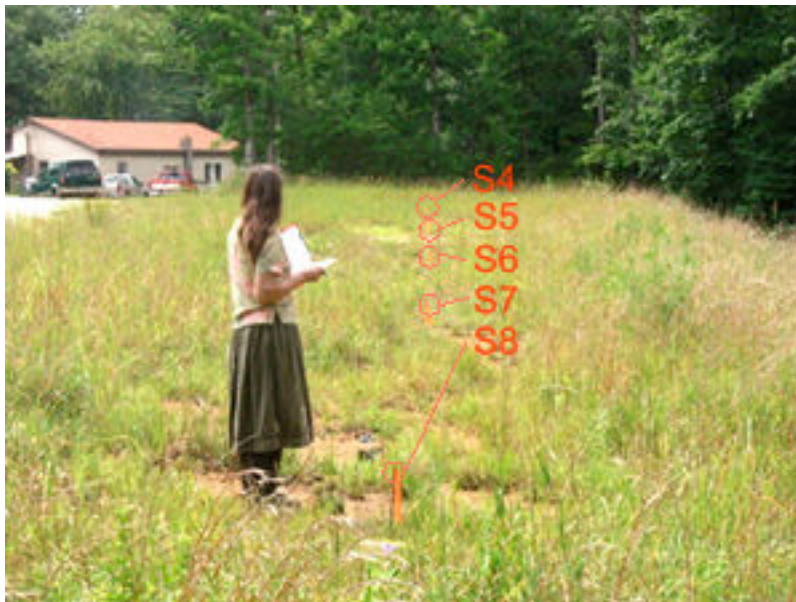
Photograph 5. Traverse through pit area with locations of soil samples. Residence is on other side of Harmon's Creek Road. Photograph taken looking west.

A second visit to the site (on 26 July 2009) was made. After measuring the extent of the black plastic and bare and sparsely vegetated area, we created a traverse line through the length of this affected area, with markers set 28 feet apart. Five markers were set, with the central marker next to a piece of thick steel cable that projected from the soil's surface.⁶ These are samples S4-S8 on the map. Samples S4 and S8 were taken outside the perimeter of exposed black plastic.

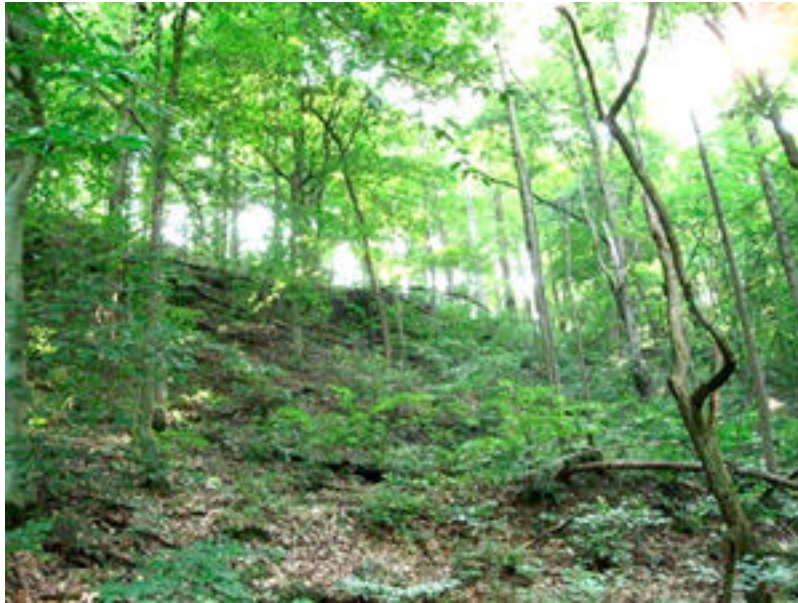
Photograph 6. Looking up hillside below the well toward the northern edge of the pad. The hillside grade is approximately 36%. This photograph was taken from the cistern area.

North of the pad, on the hillside below, three locations were tested (S9 - S11). According to our GPS these were roughly 116 to 216 feet from the wellhead.

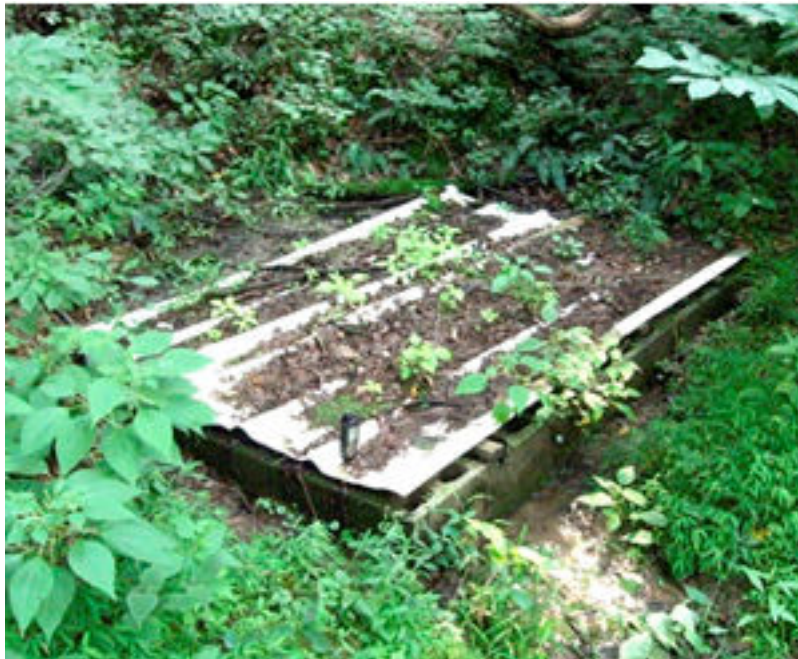
Photograph 7. The spring-fed cistern below the well pad. The cement block cistern is covered with sheets of metal roofing and its overflow drainage is visible in the foreground.

One water grab sample was taken from the spring-fed cistern on the hillside below the pad to test the water for chloride.

The conceptual model for this site includes a number of factors, some already mentioned such as the presence of a spring-fed cistern down hill.⁹ This cistern marks a point where nearby ground and surface water are hydrologically connected.
