# **Environmental Assessment for 47-079-00731 and 47-079-01492, Putnam County, West Virginia**

George Monk and Molly Schaffnit  
Poca, West Virginia  
December 2009

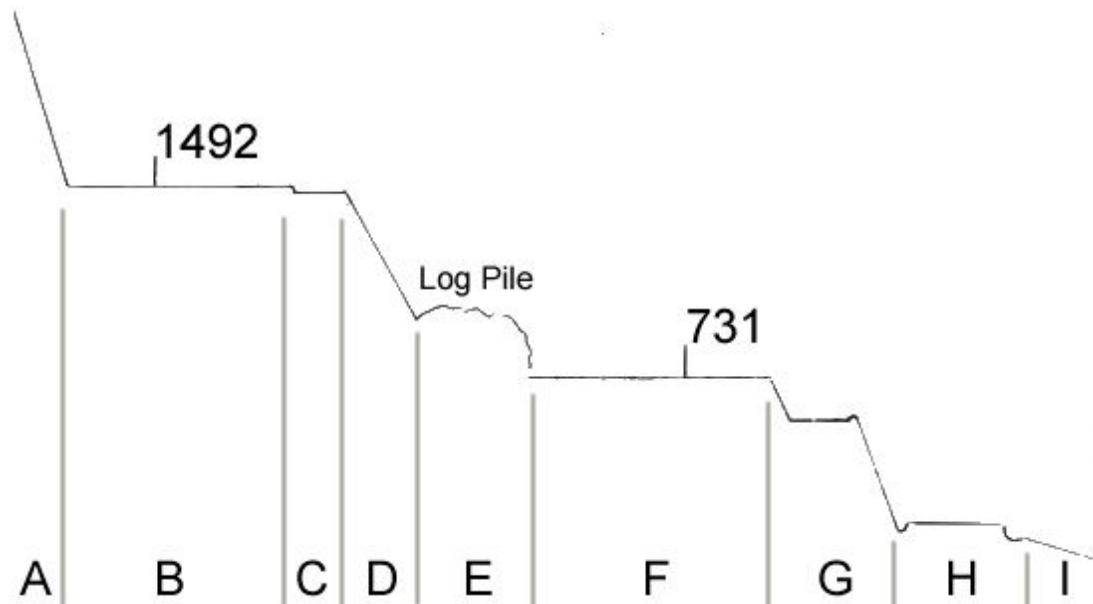
Map 1. Elevation diagram of the site. From left to right, south to north, the site is described in this report as Zones. Zone A is the cut slope above the well pad for 1492. Zone B is the pad for 1492. Zone C is the portion of the pad, including part of the pit, that slipped and is lower than the pad itself in Zone B. Zone D is the fill slope below 1492. Zone E is the log and branch sediment barrier between 1492 and 731. Zone F is the flat where 731 and the large condensate storage tank are located. Zone G is the bench below 731 and the slope from the bench to South Poca River Road. Zone H is South Poca River Road (including the ditch and culverts) and Zone I is the narrow strip between the paved road and the river.

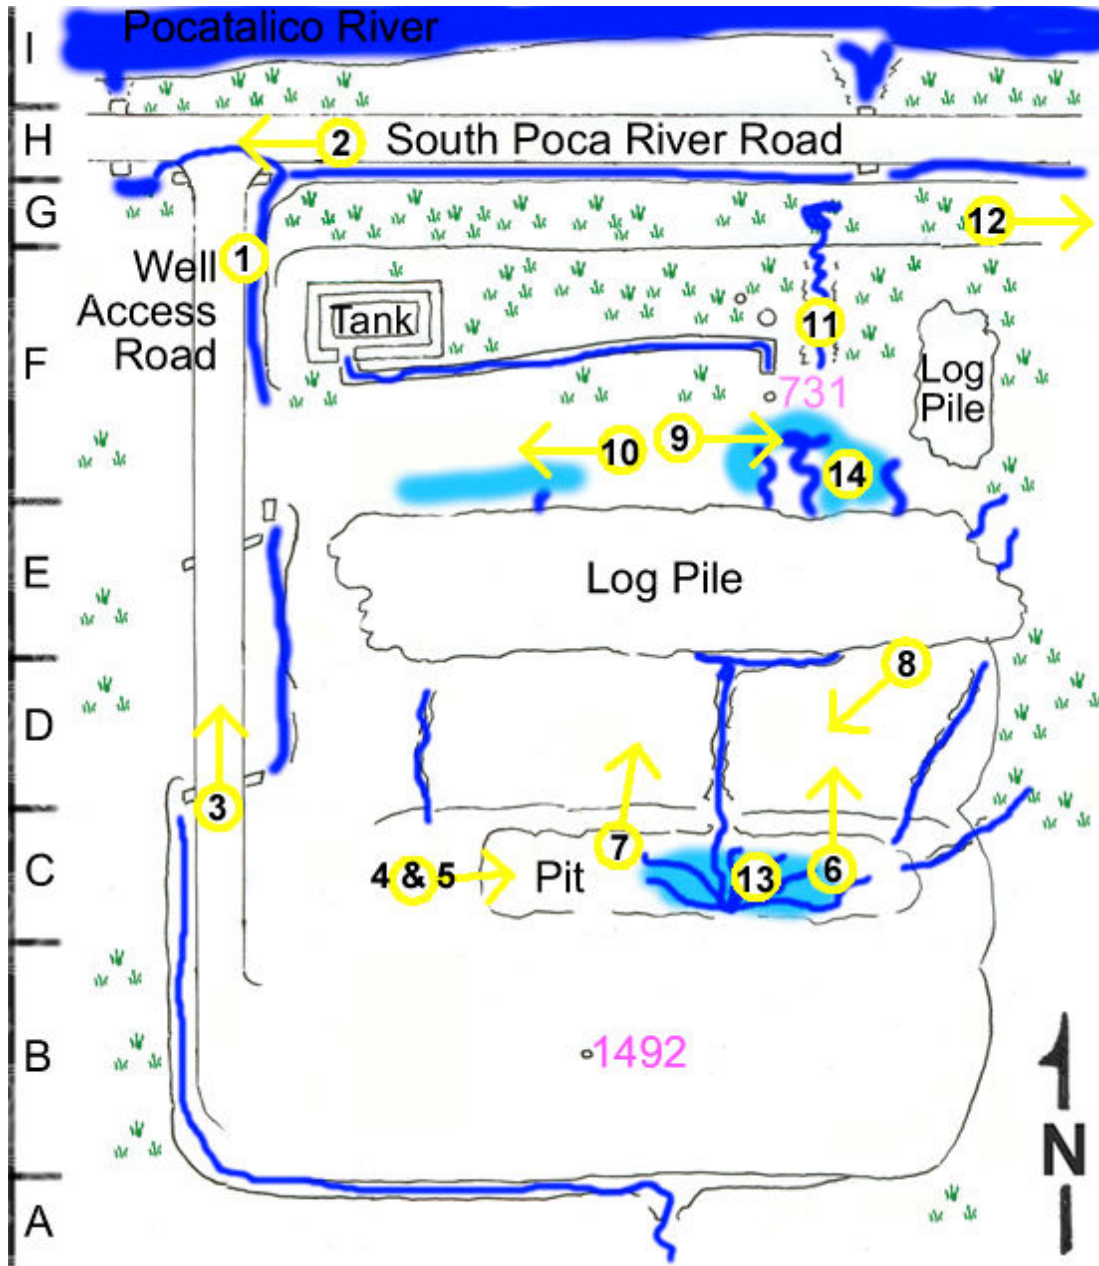
Map 2. Drainage map showing main drainage features of the site. Dark blue shows flowing water and paler blue shows large areas of standing water. Zones are indicated in the left margin. Photographs appearing at the end of this report are located on this map as numbers in yellow circles. Arrows attached to the circle indicate the direction the camera was pointed.
